Post Occupancy Evaluation

Riverside United Methodist Church

201 N Wheeling Avenue, Muncie, IN, 47303

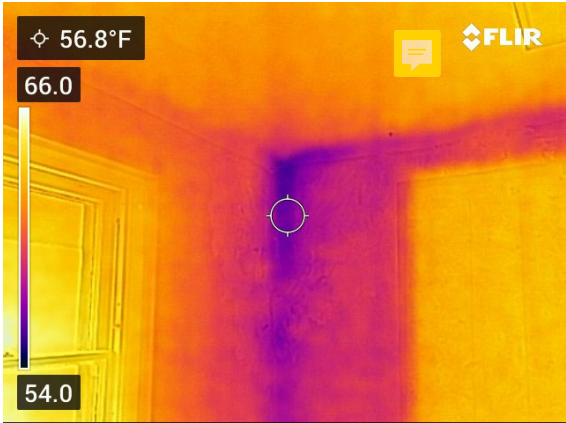
TOPIC	OBSERVATIONS	SPACES
TEMPERATURE (CM)	<ul style="list-style-type: none"><li>● Temperature 56.8 degrees</li><li>● Basement was freezing, individual heaters placed misc.</li><li>● Basement is the coldest area</li><li>● Immediately felt a draft of cold air</li><li>● Draft seems like it is coming from the windows</li><li>● Warmer in kitchen/boiler room</li><li>● Heaters placed in each room</li></ul>

A thermal image from a FLIR camera showing a room with a temperature of 56.8°F. A color scale on the left ranges from 54.0°F (blue) to 66.0°F (yellow). The image shows a doorway and a window, with a white circle highlighting a specific area on the wall.	<ul style="list-style-type: none"><li>● Educational Center</li></ul>

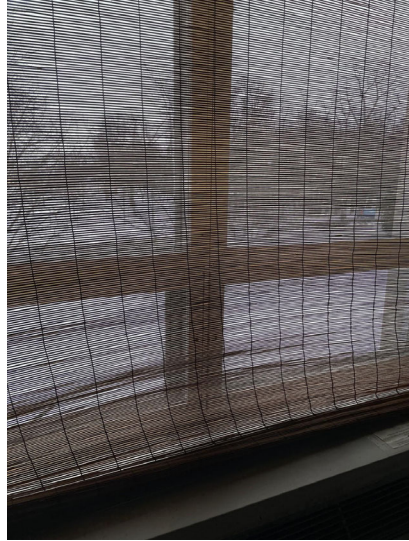
Image 2

- Draft of air from each window(s).
  - Needs sealed
  - Could feel the cold air by putting hand near the window
  - Did not have to touch the window to know cold air was coming through

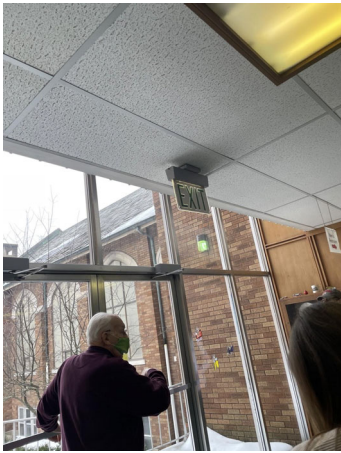
Image 13

- Exit signs
- Rails on the side of stairways
  - Carpet for anti-slip
- Unprotected electric box in main hallway

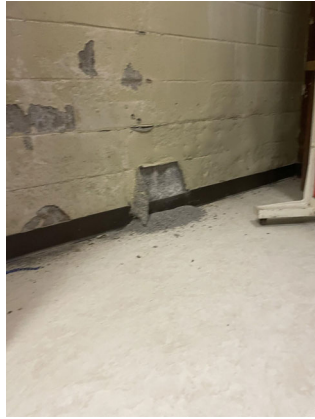
Image 15

- Janitor/mechanical closets were not locked
- Crumbling foundation in between each side of the building
  - Water damage

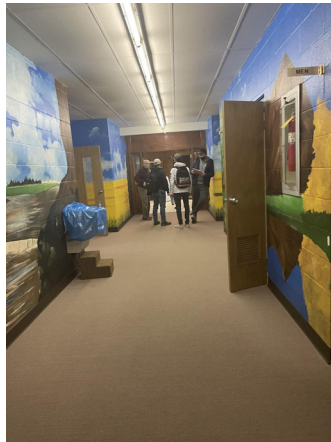
Image 17

- Lights exposed without shield in painted hallway

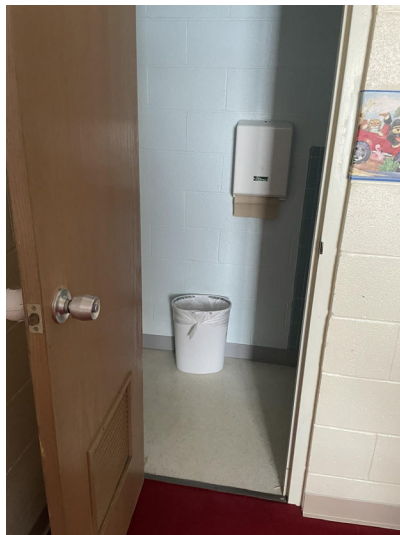
Image 22

- Small childrens restroom is hard for adult trying to help since there is minimum space

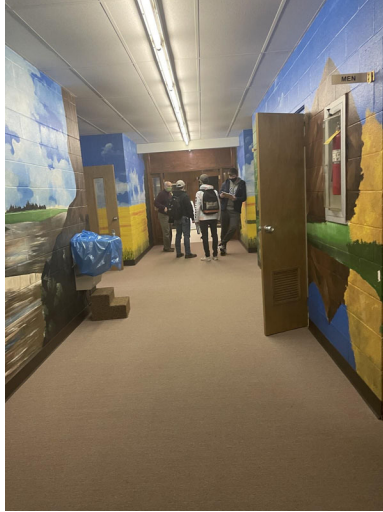
Image 31

- Painted
- hallways of educational center
- Luminaries create an unsettling feeling
  - Not very welcoming
  - Very gloomy feeling within the whole area
- Lightest by the back windows where the ramps are located due to the large windows
- Not a lot of natural light
- LEDs need replaced
- Whole Buildings

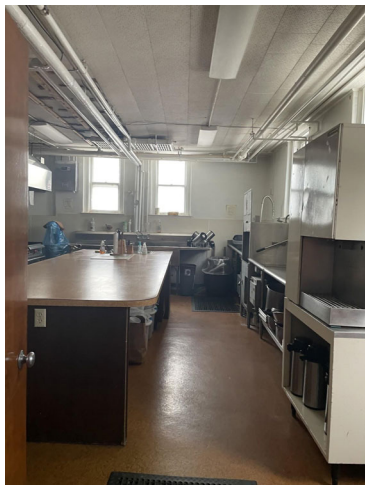
Image 34

- Ceiling tile is bare above kitchen

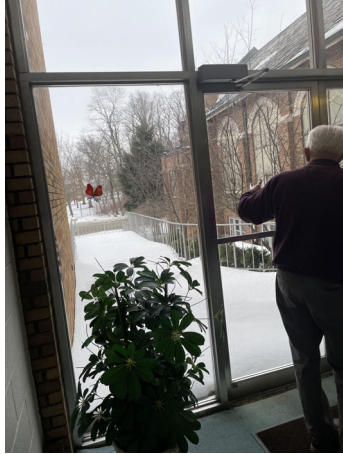
Image 39

- Entryway
- Old main entrance- now leaking water into basement wall (foundation issue)
