USING NATURE TO REDESIGN PLACE OF WORSHIP IN MUNCIE, IN
POST OCCUPANCY EVALUATION REPORT
ISLAMIC CENTER OF MUNCIE,
IMMERSIVE LEARNING GRANT

5141 HESSLER RD, MUNCIE, IN 47304
SPRING 2021

TEAM 5: Genevieve Goldthorpe, Emma Peeler, Elkah Devoe, Cylie Collins, Madison Hornung, Ben Egenolf, Austin Cain, Evan Galbraith, Ashton Hamrick

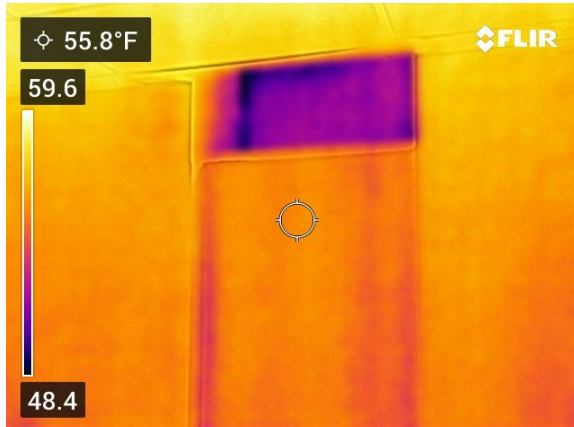
Image 1: (This window is leaking cold air around the seams of the window - The darker purple colors demonstrate the cold air.)

1. Install better installation in the walls, especially around the windows to prevent heat loss.
2. Caulk or replace the windows, to create a tighter seal preventing drafting and heat loss.

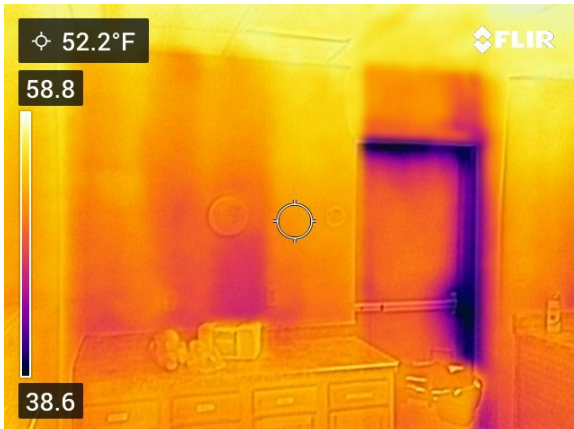
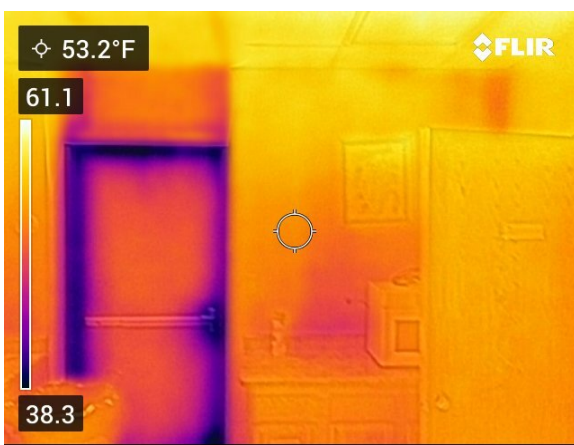
Image 2-3: (This is an image of a basement door connecting to the exterior. This door is leaking cold air around the frame- the purple color.)

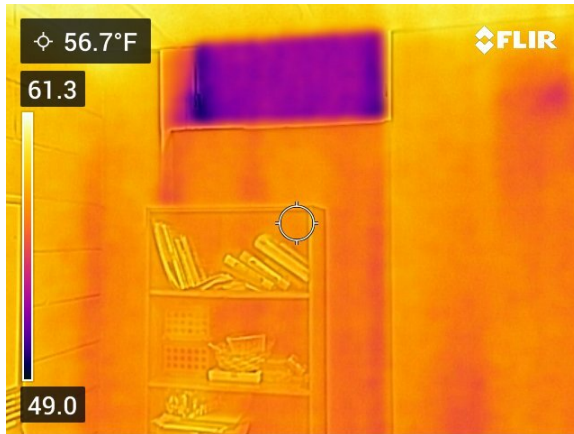
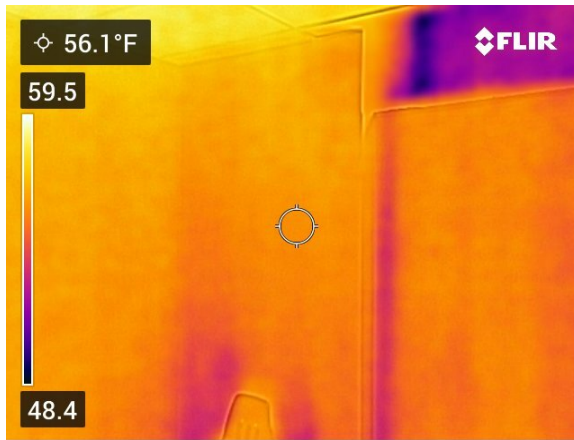
Image 4-5: (This is another image of the basement window. It has the same issue with leaking cold air around the seams. The cold air entering the windows causes higher bills for heating and drafty rooms.)

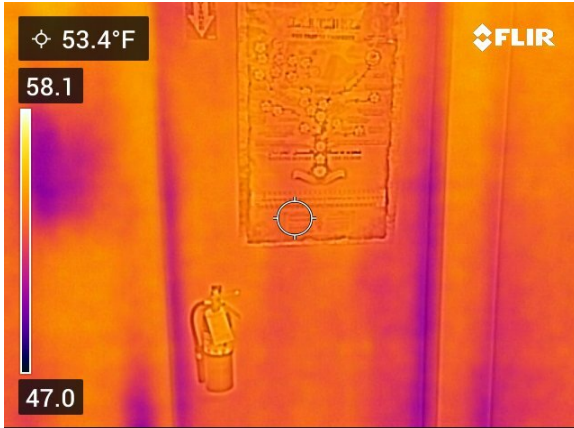
Image 6: (This is a picture of the interior walls of the basement. This shows that there is not proper installation within the walling. The purple areas demonstrate where installation is lacking tremendously.)

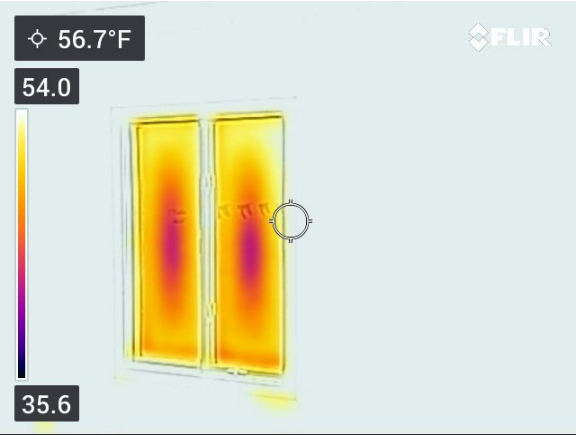
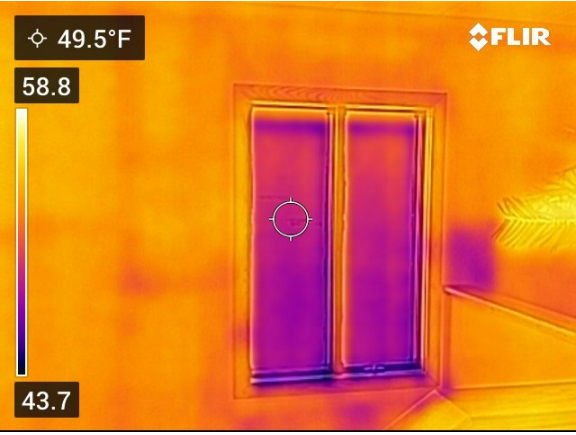
Image 7-8: (Are a few windows upstairs near the basement staircase. The purple areas demonstrate where installation is lacking tremendously within the wall around the windows. The windows themselves are also leaking cold air around the seams.)

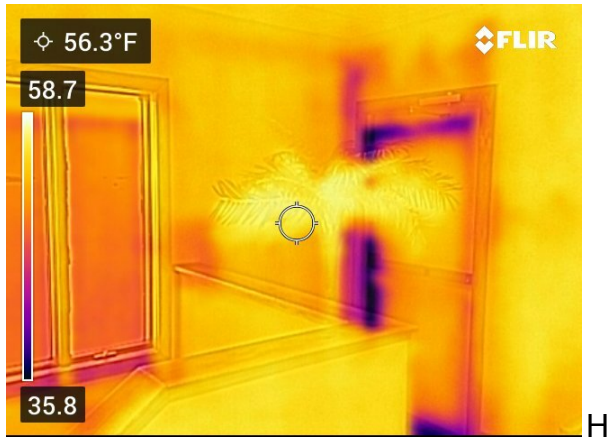
Image 9: (This is an exit that is located upstairs near the basement staircase. The purple areas demonstrate where it is cold meaning that the door does not seal properly)

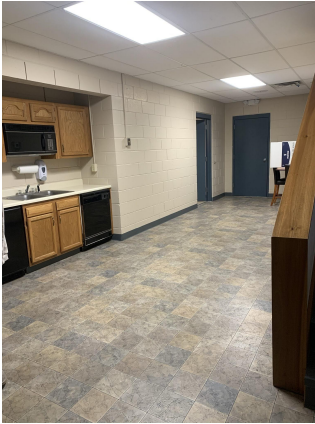
Common space in basement:

Little to no natural light. Bright artificial lights.

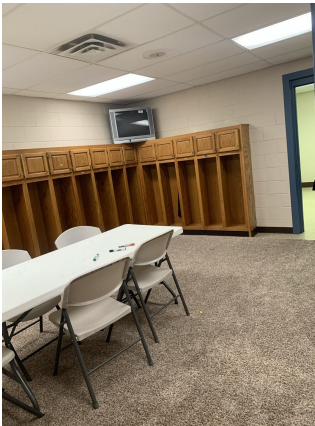
Gathering space in basement:
No natural light creates a non-relaxing environment.

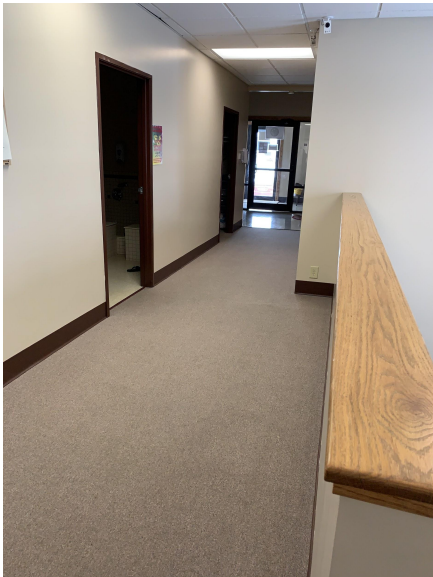
Hallway to the basement staircase: (G) hallways could use different lighting (LED), the hallways are a little dim.

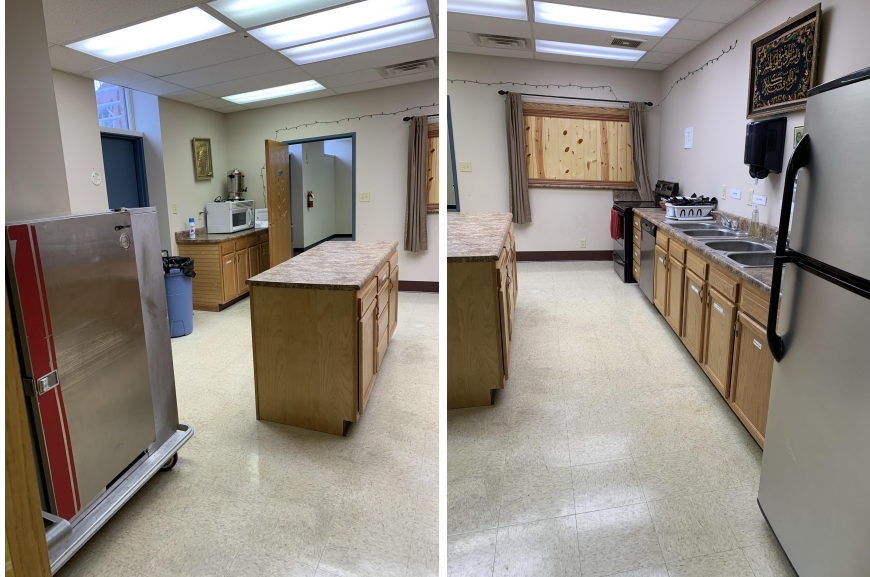
Kitchenette downstairs: (M) Lighting is very minimal. Makes the area seem gloomy.

4. The lighting needs to be adjusted throughout the whole building to create a warmer, more welcoming place. LED lights would be recommended for brightness. The switches in the basement should also be rearranged to create a safer environment. Many areas in the basement, such as the room off of the kitchen, have switches in random areas. A switch should be located at each door so people have light when entering a room.

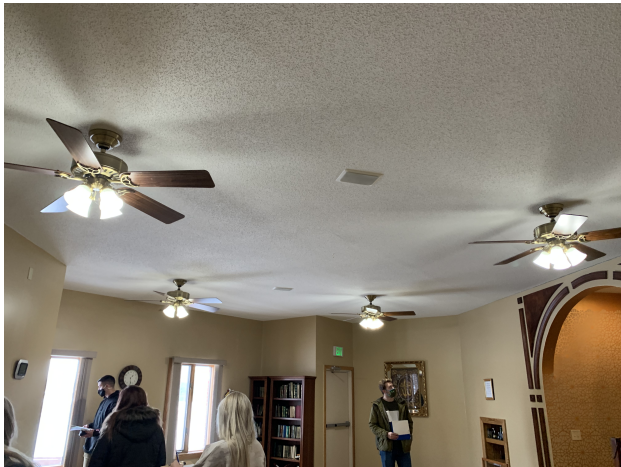
(N: Pray Room) - there are several fans, but the air still is not moving throughout the building. Is having so many fans effective? Or should we find a new solution to circulating the air?

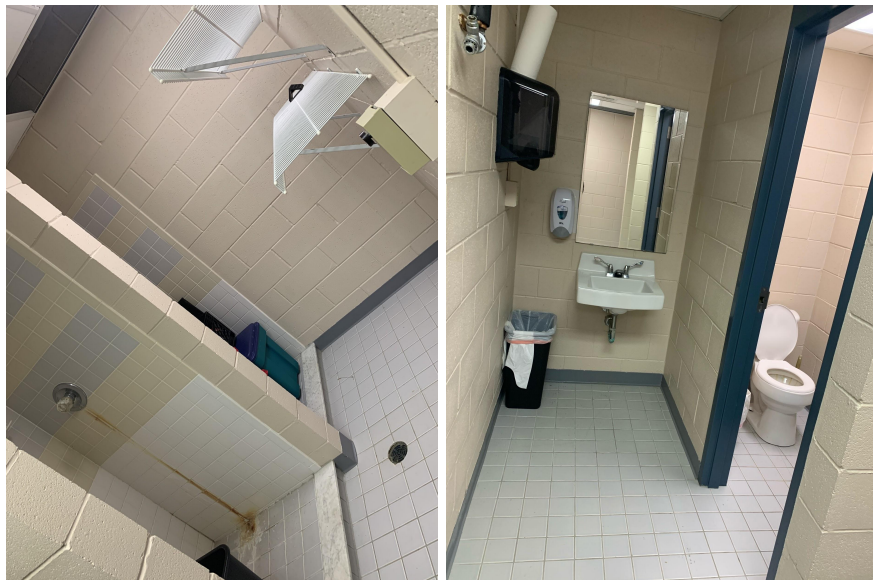
(H: bathroom in basement)

- Bathrooms are not up to code/inclusive - lighting in bathrooms are poor, the shelving could be harmful, no handle bars for inclusivity, paper towel and soap dispensers can be positioned better and censored for inclusivity. Showers are very small, with no handles, no privacy, water could easily flood the flooring.
- The showers were also not clean at all. Looking into something that is more commercial material and more durability would work better. A material that does not get dirty as quickly or easily is recommended.

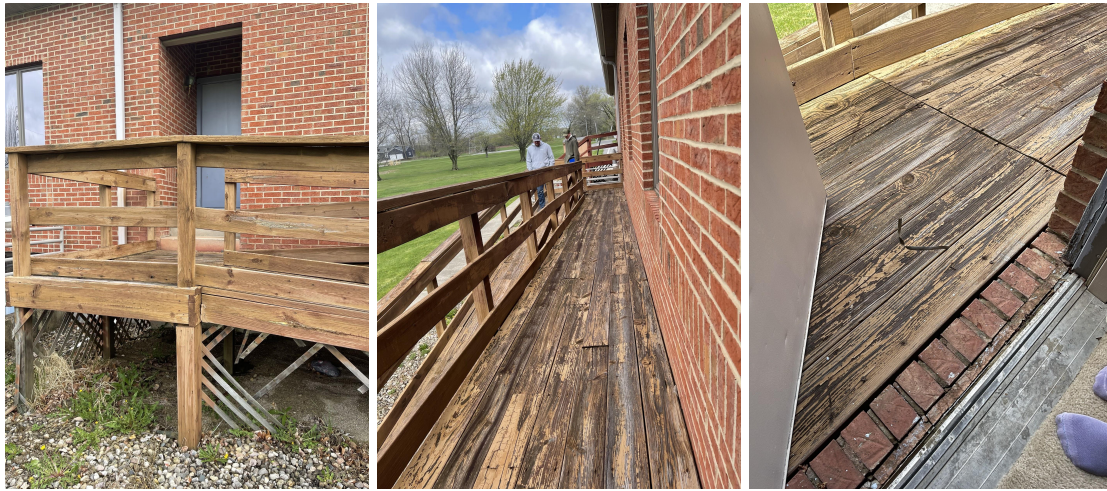
(ramp leading from the women's prayer room)

Some of the basement doors did not open either. Exit off of the prayer room is damaged and is very hard to open. Once the door is open it leads to an old decayed ramp.

The priority recommendations would be focusing on the ramp on the back door, installation, lighting and windows. The other recommendations are cosmetic that would create a more welcoming environment but are not crucial.

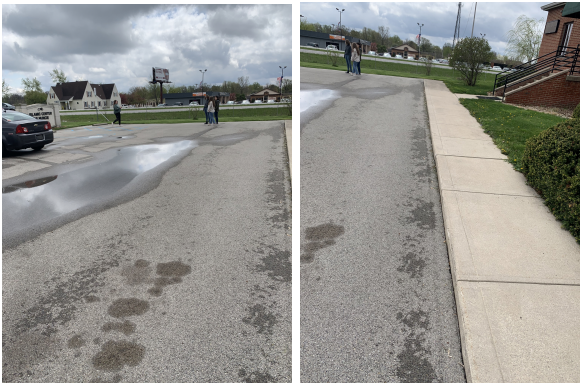
(Images show the only two handicap parking spots in the corner of the lot and the sidewalk right across from the spots. There is no smooth transition for wheelchair to get up on to)

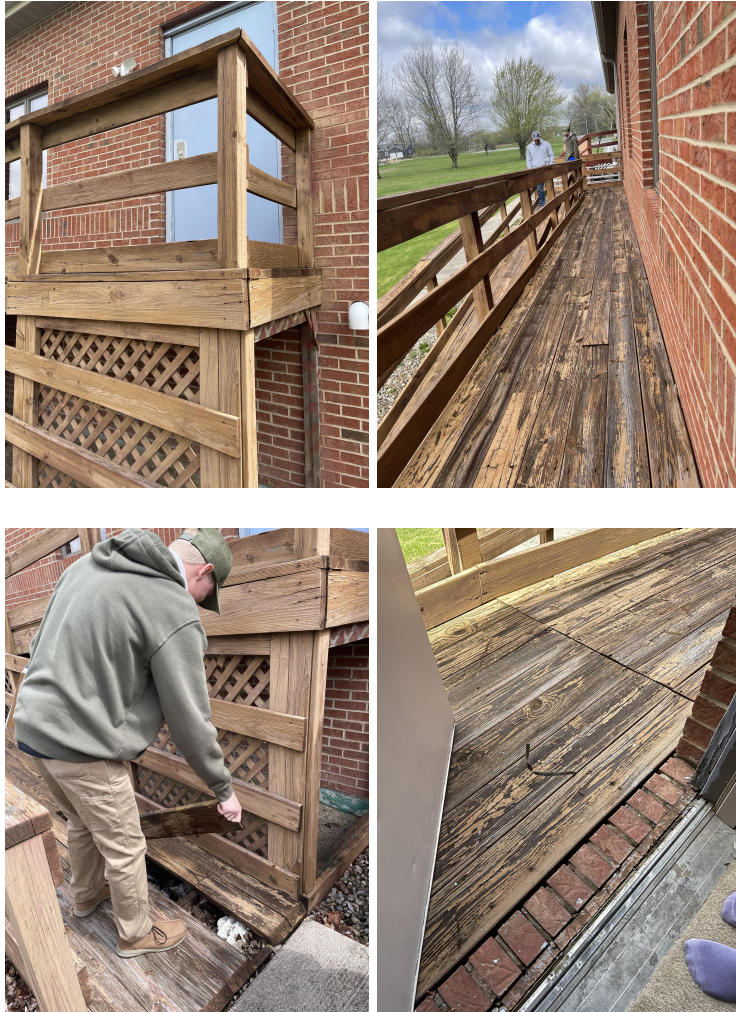
Back entry ramp:

There were no ramps in the front of the building- there was only a single set of stairs. There was a ramp in the back of the building allowing access to the first level but the ramp was an old, wooden wrap- would be beneficial to fit a ramp within the main entrance for inclusivity.

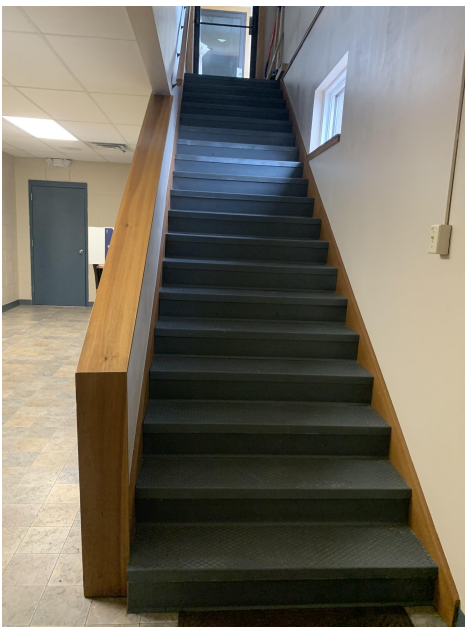
-There is only one ramp and that is located in the back of the building but the ramp is not up to code. The exterior back ramp is also extremely hard to access.
-There is not a ramp to access the basement of the building.

(H) stairs going to the basement.

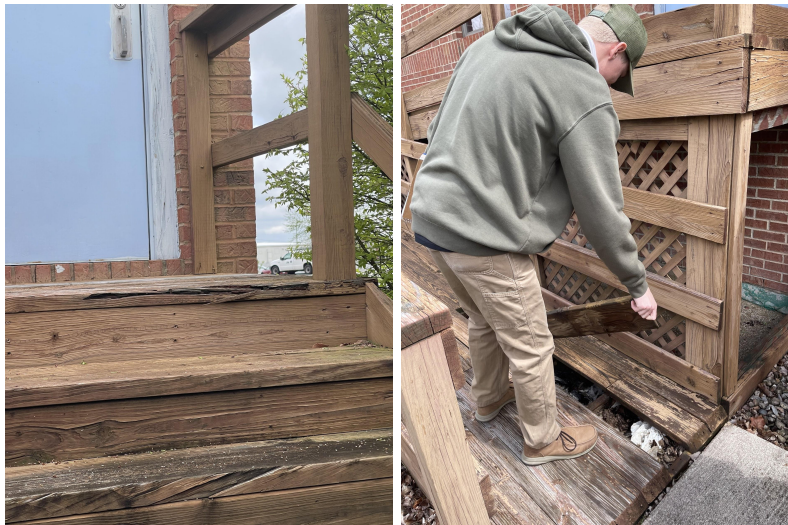
(The staircase found outside on the back wall is rotten as well as the wooden ramp on the back side of the building.)
