**Provost Immersive Learning Grant
Using Nature to Redesign Places of Worship in Muncie, IN
Spring 2021: Post Occupancy Evaluation
Islamic Center of Muncie: 5141 Hessler Rd, Muncie, IN 47203**

**ID Members: Abby Sprague, Halle Schrank, Lauren Cloonan, Lesli Mackey, Therese Jirgal
CM Members: Anthony Kahl, Matt Combs, Nathan Witty, Dayton Webster**

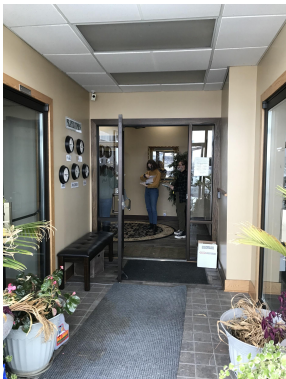
#1

- Fluorescent lighting used in this space
- Natural lighting coming from large curtain wall- brightening the interior space
- One ambient can light in vestibule

- Cold in the entry with both doors propped open
- Vestibule does not do great separating cold outdoor air from interior

- Could hear voices from the entrance when in the prayer room no door to blocking noise between these two spaces.
- Slight echo in entrance with higher ceiling

- **Wall:** beige paint with rubber base
- **Floor:** vinyl mimicking wood and brown short ceramic tile
- **Ceiling:** popcorn ceiling

- The finishes are easily cleanability
- No slip resistant flooring or walk off carpet.
- No transition strip between tile and vinyl flooring leaving a slight height difference between the two.

- Wall next to final entrance door is beat up slightly
- Floor good quality and little wear

- A lot of natural light
- Connection to nature through the views
- Ineffective use of potted plants

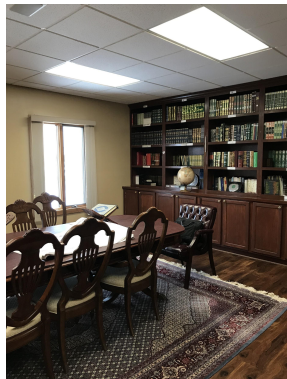
#2

- Fluorescent lighting 2'x4' work as ambient lighting for space
- Windows
- provide some natural lighting
- Possible Dimmer to control lights and lights appear motion sensed

- Air quality and thermal comfort appears sufficient, no draft

- Enough seating for multiple people around the table and extra people if needed
- Bookcases built in casework goes up to eight foot ceilings. Books on the top shelf may not be reachable to all users.

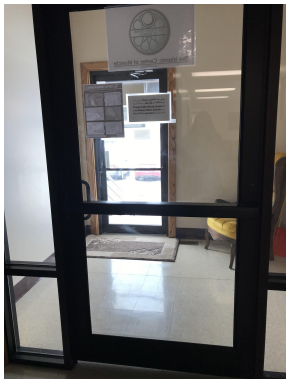
#3

- lighting is dim in this space
- An artificial light created hot spots on the ceiling. This lighting is a residential style luminaire
- One ambient can light in vestibule

- This vestibule space did not have a draft

- **Wall:** lighter paint then paint used in entrance and men's spaces (lighter beige)
- **Floor:** vinyl tile probably 1' x 1' flooring (different from other spaces)
- **Ceiling:** white painted popcorn ceiling texture.

- Some natural lighting

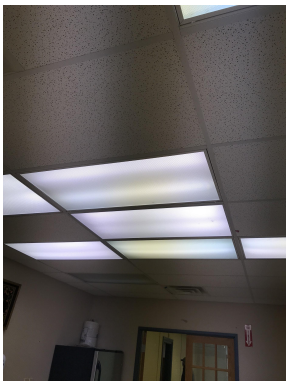
#5

- Uneven lighting with 2' x4' fluorescent lighting next to each other above the island in kitchen space.
- 2'x4' fluorescent lights are also used in larger and smaller dining areas. In the larger dining areas there are dark corners.
- A number of clerestory or awning windows provide some natural lighting throughout the basement.

- All the spaces in the basement were very cold due to the lack of insulation.
- Holes in ceiling allowing air flow into the breaker room which is connected to the smaller dining area and classrooms communal space.

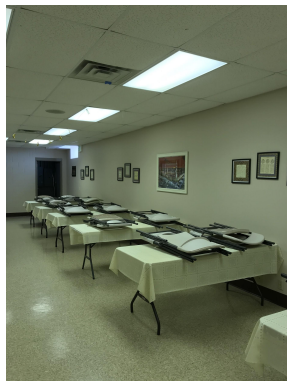
#6

- **Wall:** Walls in larger dining areas are covered with acoustical wall cover material. The baseboard used in the large dining space is blue and rubber.
- **Floor:** vinyl
- **Ceiling:** 2x4 ACT ceiling, light fixtures dispersed unevenly
- **Older appliances:** 2 sinks, Dishwasher, refrigerator, oven/stove
- **Furniture:** Non permanent foldable tables and chairs
- **Appliances in Second kitchen/kitchenette area:** dishwasher, ice maker, microwave, and sink
- Exposed concrete support columns

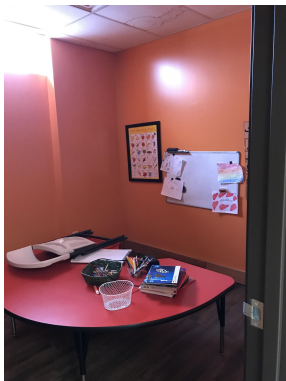
#7

- Communal area between classrooms has

ineffective lighting with 2'x 4' fluorescent lights butting next to each other so no lights close to or near walls.

- Yellow room 2 clerestory windows
- The yellow room paint was causing natural light from the windows to reflect off forming glares.
- Blue room 1 clearstory window
- Orange room 1 clearstory window

- The temperature in each room was cold most likely due to the lack of insulation.

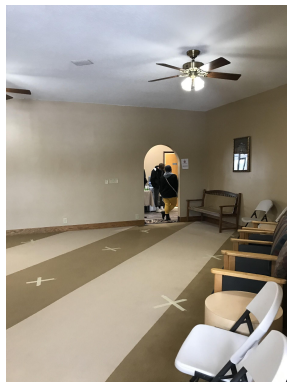
#10

- Poor lighting with ceiling fans have four luminare built into them projecting light up and to the side rather than down.
- Two windows in each prayer room bring in some but limited natural light.
- Many dark corners in both of the two prayer spaces due to the uneven natural and ambient light.

- There were many ceiling fans in the two prayer rooms for air circulation
- Multiple vents; none of them were covered.

- The space has good circulation with separate rooms for men and women. A door is accessible between the spaces which allows access from one room to another.
- The doorway into the men's prayer space leads from the men's closet and restroom. The door into the women's prayer space leads from the women's closet and restroom so easy access for all users.

- Mismatched chairs unfit for large gatherings
- The chairs are also lined up against

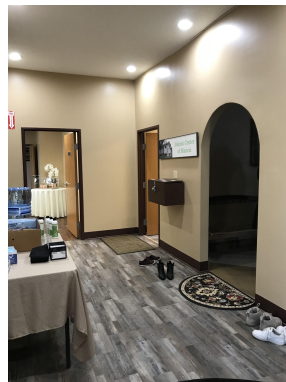
#12

- This entrance or all other entrance into the building are not accessible. As there is no ramp for easy access and all basement exits are below ground level.
 - Ramp in the rear of the building but it is not accessible (does not meet ADA)
 - Appearance to be only an emergency exit as there is no place to remove shoes if the ramp is used
- Front entrance only accessible by using steep stairs at a slight slope.
- There is a lack of signage throughout the building so the space is not easy to navigate. Including a lack of emergency exit signs.

- The entrance is small and narrow for a public space. Once past the vestibule the space widens.
- The entrance is clearly being used with marks on the painted wall and use of a high traffic entry rug.

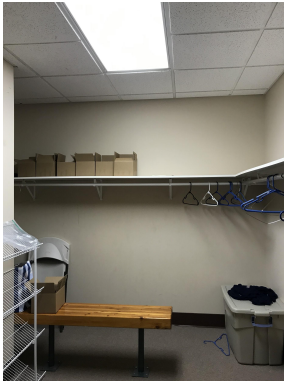
#13

- Steep Stairs could be physically challenging to employees and staff
- The male and female closet has a low height coat rack and shelves which are easy to access for most individuals.

- Bench under prayer times is unusable because if used the clocks would most likely be knotted down.
- Information table is plain and looks out of place and is an obstacle in the circulation space.

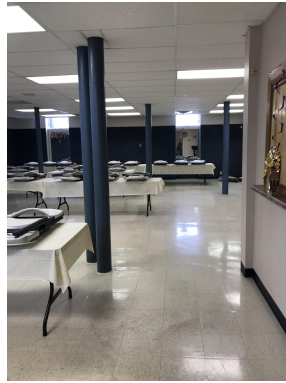
#15

- Open floor plan in the two dining areas.
- 6 Structure columns in the large dining space divides the room.
- There is a lack of storage to store foldable chairs and tables in the small and large dining space.
- Larger and smaller dining areas separated by kitchen. Users of the space must go through the kitchen to get to the larger dining area.
- Small island in the center of the kitchen
- Appliances are not built in

- There is no use of wayfinding so the basement can become confusing with many doors and corridors.
- There are few signs and no signs marking emergency exits

- Some drywall and paint beat up throughout basement
- Ceiling tiles have water stains and warping

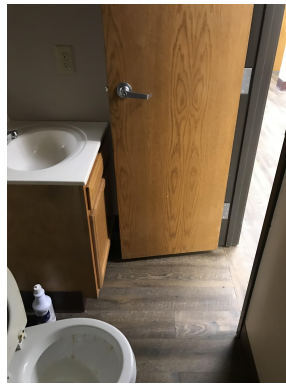
#18

- Small Bathrooms with child size toilets placed in the center of one person restroom cause space on the one side of the toilet to be useless. small non accessible door
- Stairs in communal classroom space lead up to the female side of level one resulting in a circulation path for the children to cut through the women's space.

- Communal classroom space for playing connects the three classrooms and the children's restroom.
- Awkward rooms shapes and two doors to access blue and yellow rooms.
- A lack of storage for storing toys and supplies

- Signage marking classroom doors with colorful letters
- The children's bathroom does not have an accessible door with the doorway width mostly likely less than 32" and little room if an adult is needed to be present.

- Only kid-sized tables and seating which are not very comfortable for adult staff.
- Little open space to walk and move around in classrooms.
- Small kids bathroom little space to move around in and vanity may be too tall for younger children.
- The bathroom door is also clearly not 32" wide.

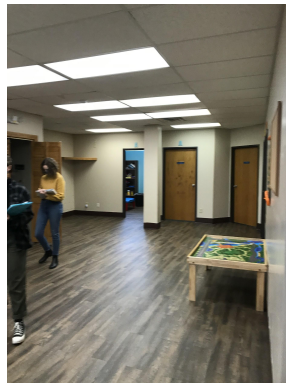
#19

- **Wall:** vibrant paint color rooms (orange, yellow, blue) outdoor communal space is light beige paint
 - **Floor:** vinyl
 - **Ceiling:** 2' x 4' ACT ceiling
- Quality:**
- Water heater/furnace equipment open to children
 - Many ceiling tiles have stains and are warping

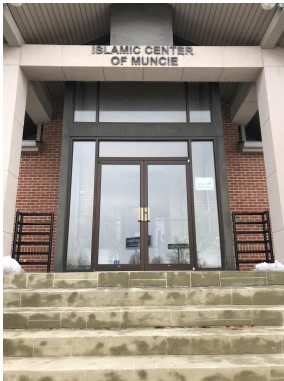
#21

- The building is not accessible to all users because there is no ramp. A U shaped ramp or a L shaped ramp could easily be added to the front exterior.

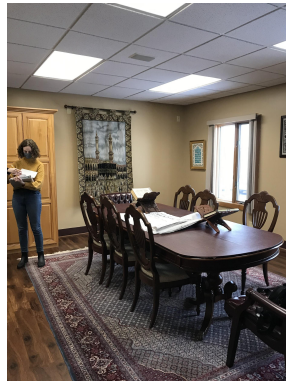
#22

- Finishes in this space show little wear.
- The quality of furniture is in good condition and appearance to be sturdy.
- One cabinet door by the far wall on the lower case work of the book case is slightly beat up.

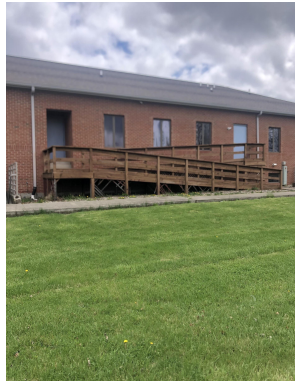
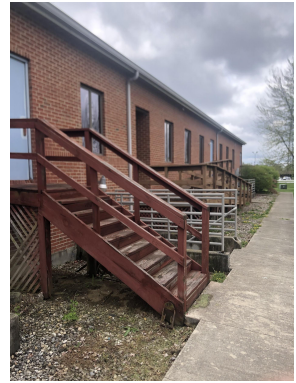
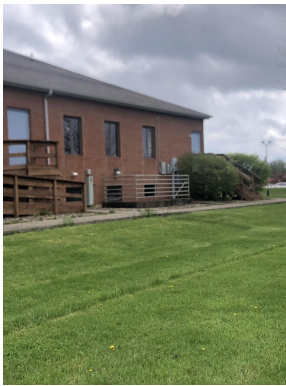
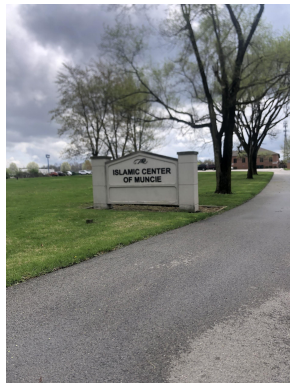
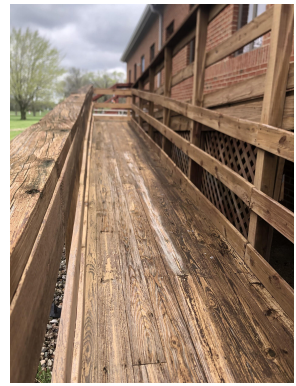
- brick exterior
 - 5 back staircases
 - 3 front entrance
 - Main sign is difficult to see until you are already passed where you need to turn
 - Rear ramp is rotting and doesn't seem safe to be used
-
