RIVERSIDE METHODIST CHURCH POST-OCCUPANCY EVALUATION

Project Title: Using Nature to Redesign Places of Worship in Muncie, IN

Spring 2021 work: Post Occupancy Evaluation

Site: Riverside United Methodist, 1201 Wheeling Ave, Muncie, IN 47303

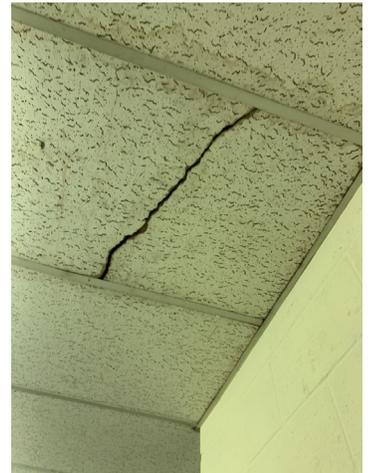
Yes, but many of the ceiling tiles were falling out/damaged ceilings. (Reference Photos 3, 5, 6, 7, 9, 10, 13, 26)

3 - Cracked ceiling tile

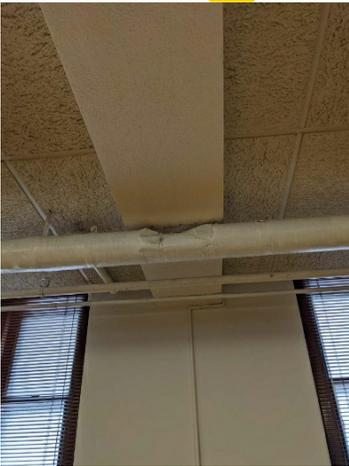
4 - Damaged pipe

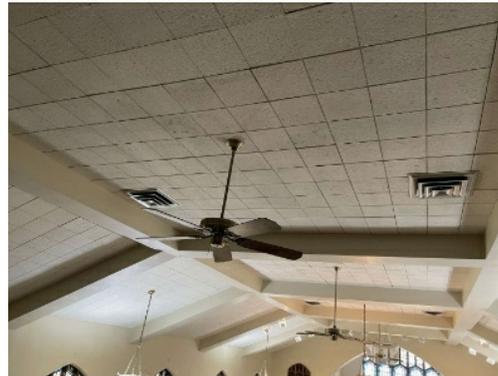
Did not see mold, but there was a lot of water damage and mold might be in walls, ceilings, and floors. (painted over?) (Reference Photos 5, 6, 10, 13, 21, 24-26)

Water damage (Reference Photos 5, 6, 10, 13, 21, 25, 26)

5 - Ceiling - water damage

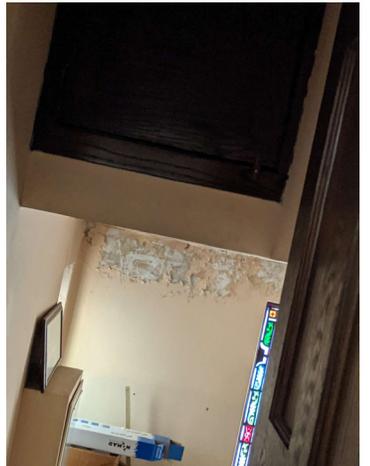
6 - Ceiling water damage

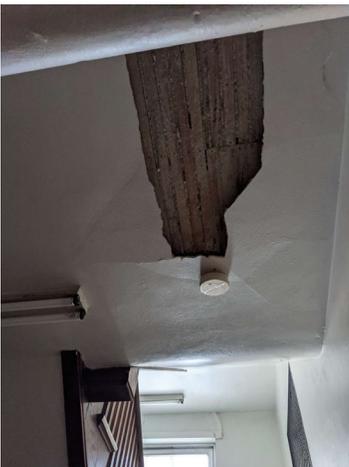
7 - Damaged ceiling

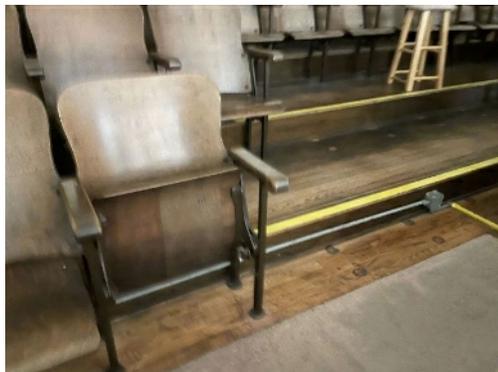
Wood stain of pews and chairs had some chips and fading. (Reference Photo 8)

8 - Balcony seating - fading

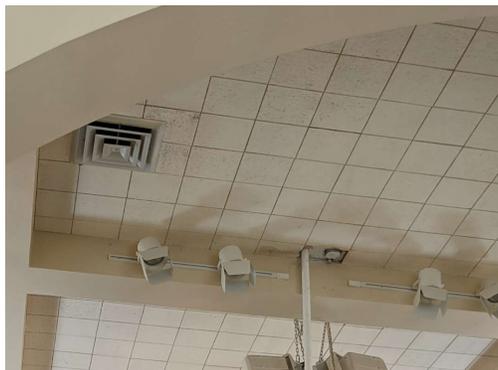
10 - Water damage around ventilation

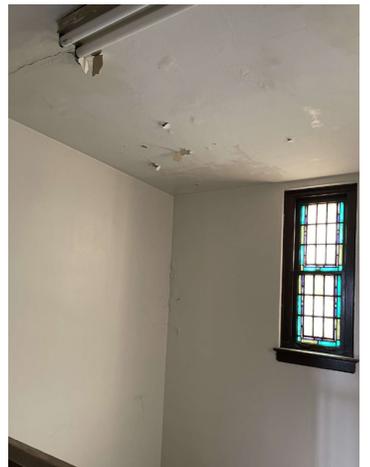
9 - Paint chipping on ceiling

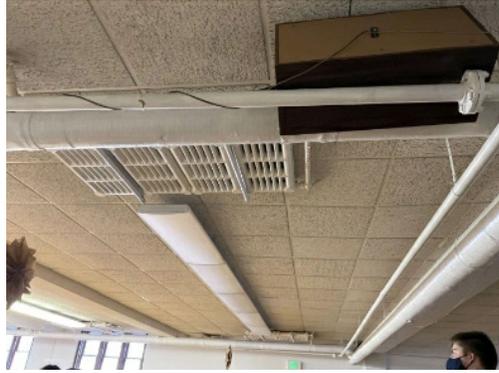
For the most part, yes. There are a few instances where a cord is running up a wall or wrapped around a pipe. Closer outlets would fix this problem. (Reference Photos 12, 43)

12 - Cords wrapped around pipes

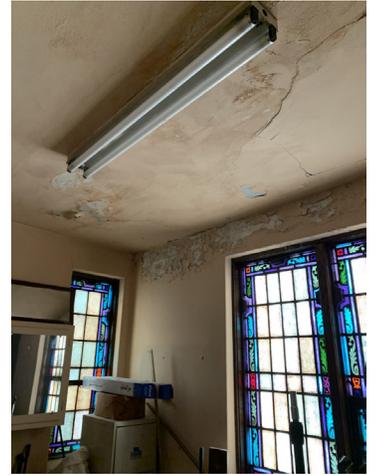
13 - Water damage on ceiling and wall

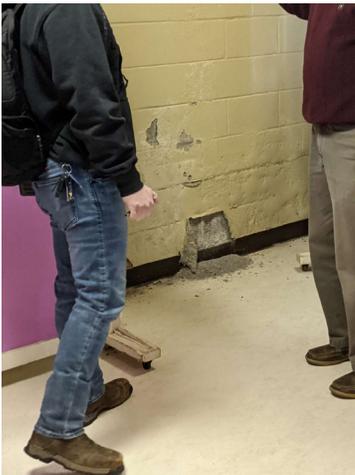
14 - Rotting concrete wall

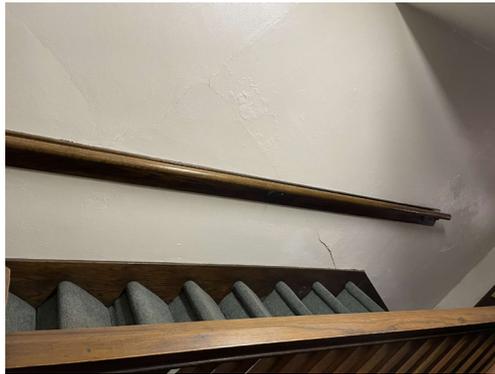
15 - Stairwell with cracked wall

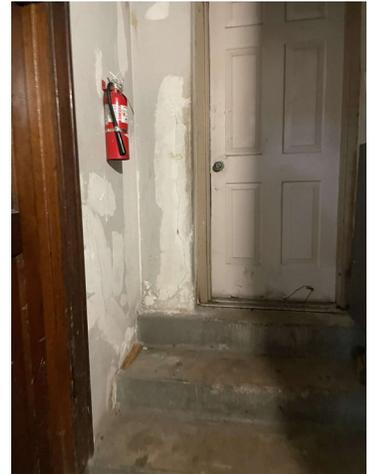
16 - Patched paint on wall

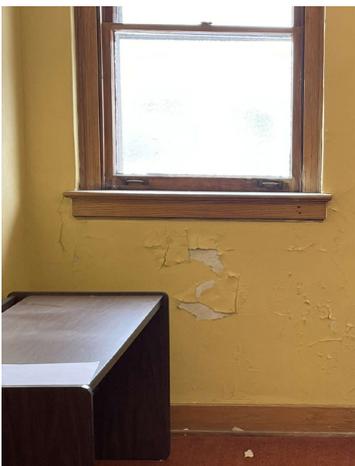
17 - Paint chipping on wall

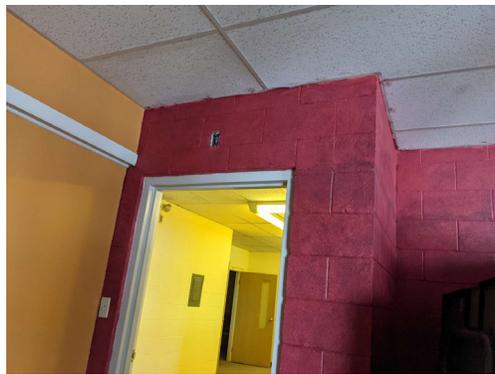
18 - Poorly painted wall (spots on ceiling)

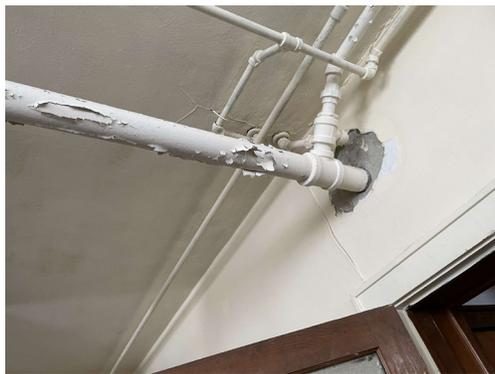
20 - Paint chipping on pipe

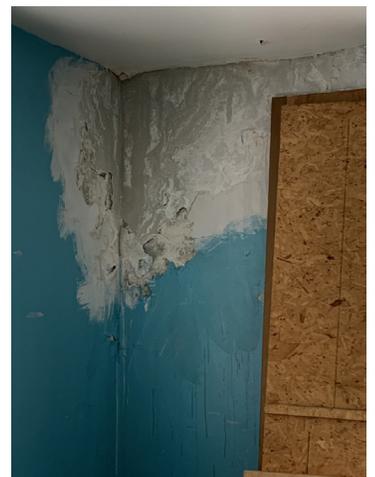
Water damage (Reference Photos 19, 24, 25, 26)

19 - Damaged wall

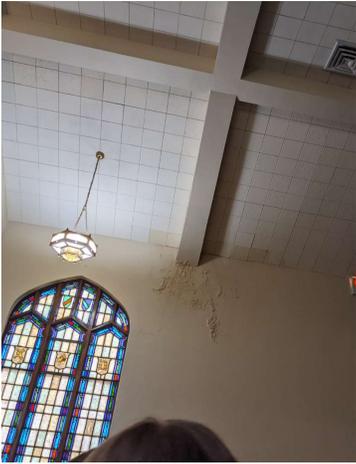
21 - Water damage in sanctuary

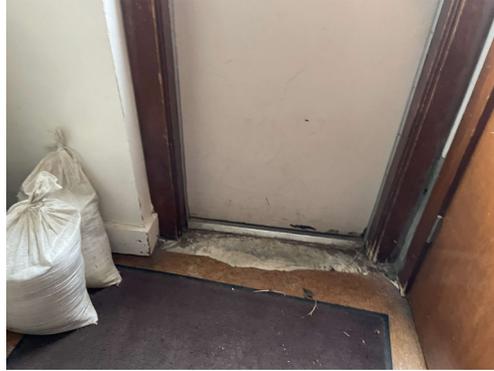
22 - Damaged threshold

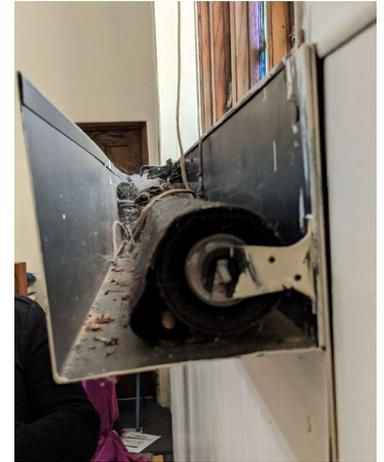
23 - Curtain rod - dusk build-up

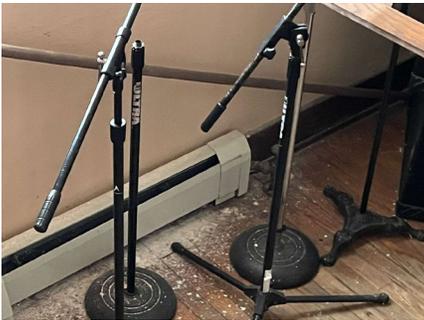
24 - Water damage in storage area

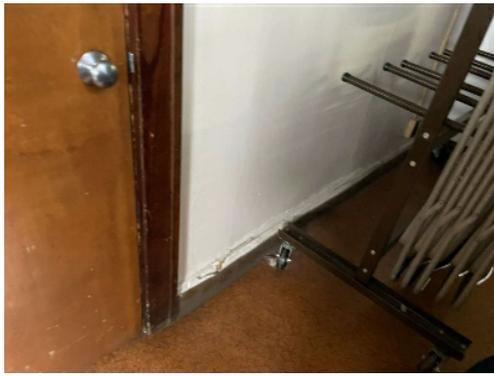
25 - Water damage on trim

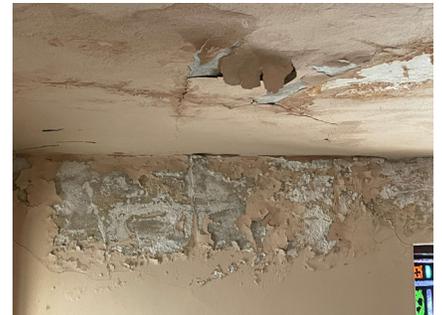
26 - Water damage and paint chipping on wall and ceiling

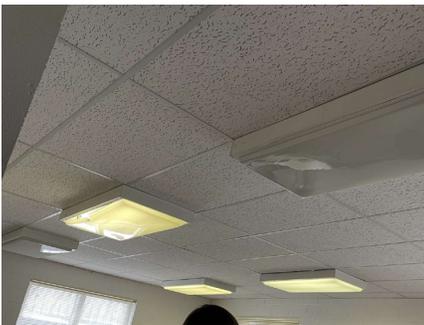
Lights were not centered, broken, falling out of ceiling. Large light fixtures, but did not let off a lot of light. (Reference Photos 27 – 32)

27 - Broken luminaires, burnt-out lamps

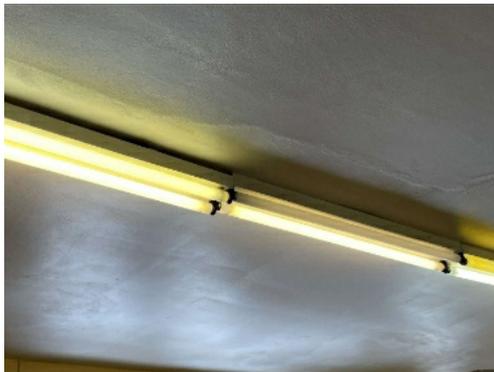
28 - Dim, yellow lighting

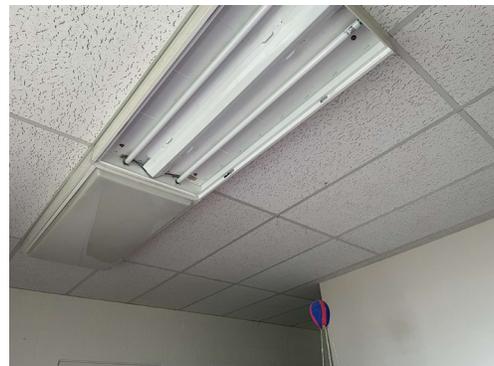
31 - Luminaire with missing cover

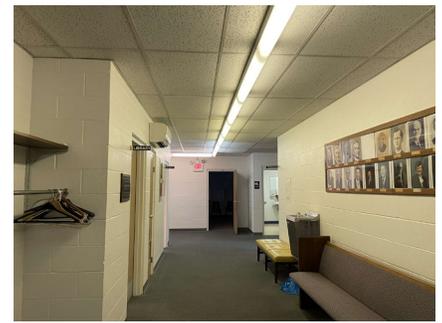
32 - Dim lighting in hallway

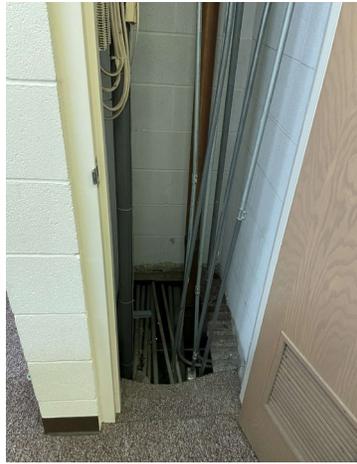
Older plumbing fixtures/pipes, year unknown; located in paperwork of building systems, but access was not available during visit. (Reference Photos 34, 37)

34 - Mechanical closet, pipes

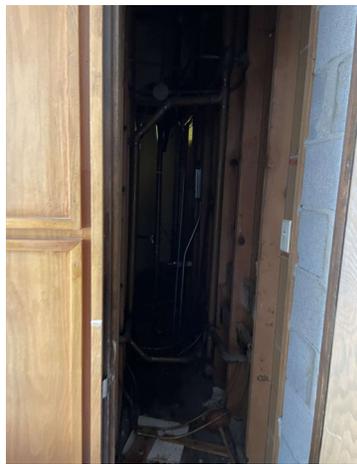
37 - Mechanical closet, pipes

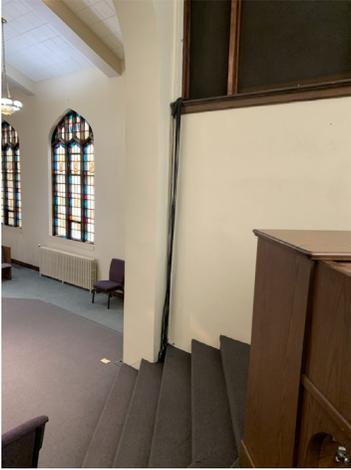
43 - Cords going down wall

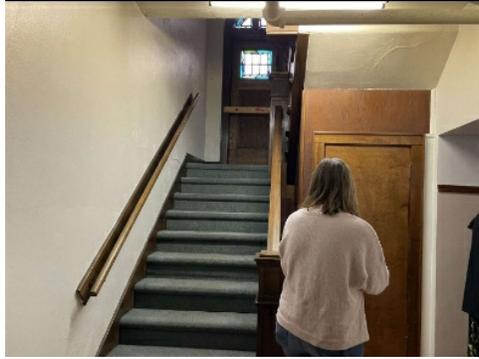
44 - Steep stairwell

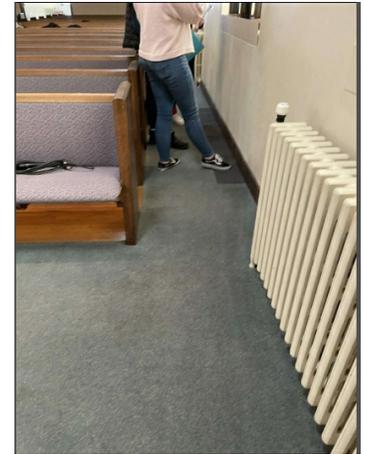
Some carpet was fading. In the basement the carpet had no carpet padding. There are carpet patches in some areas. Some stains on floors. (Reference Photo 48)

48 - Patched carpet in sanctuary

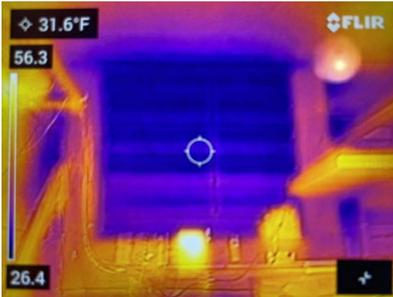
TC-1 - This is a garage type door in the basement next to the boiler room, showing a large amount of heat being lost through poor sealing and no insulation on the door. Although this room does not necessarily need heated it will lose common room heat if the door to the boiler room is left open

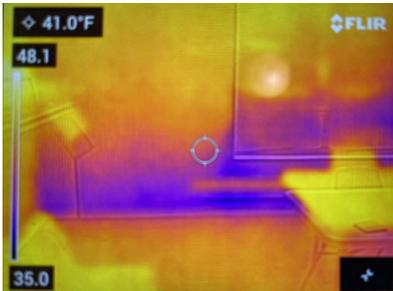
TC-4 - This is another angle of TC-3 showing the extent of the damage.

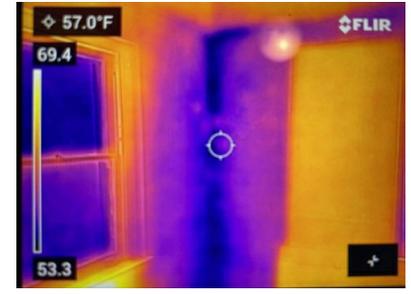
TC-13 - With a closer view of the corner, it becomes clearer that there is water damage in the wall. This should be addressed, or it will lead to more deterioration and a more costly fix in the future.

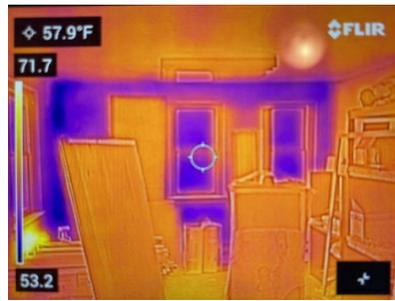
TC-15 - More missing insulation in an upstairs storage room. Renovation becomes more of a necessary decision throughout the process locating multiple rooms losing heat and driving the heating and cooling bills up.

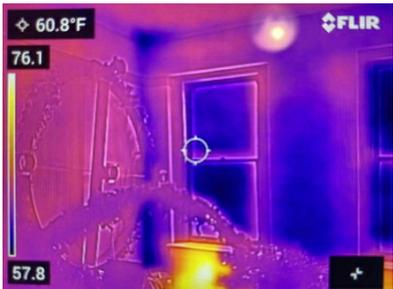
TC-17 - Another upstairs storage room shows extensive insulation damage and possible water damage down the corner of the wall.
