POE

TEAM 1

RIVERSIDE UNITED METHODIST CHURCH

1201 WHEELING AVE.
MUNCIE, IN 47303

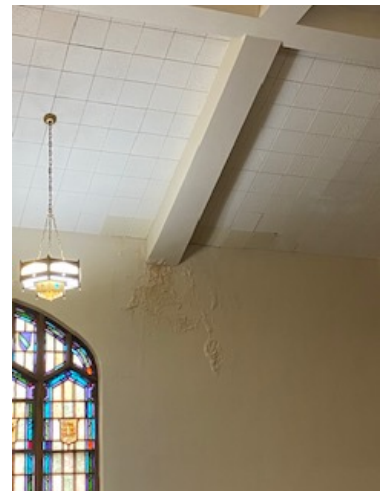
- Finishes (floors, walls, Ceilings, etc.)Poor, **Average**, Good
 - Needs newer carpet flooring, NOT aesthetically pleasing (suggest carpet tile)
 - Walls need work- water damage, needs fresh paint (suggest beige)
 - Ceilings need work- water damage, needs fresh paint (suggest bright white)
- Color (dark/light)Poor, **Average**, Good
 - Depends on time of day (too much natural light dependency)
 - Incorporate better interior lighting
- Furniture/Furnishings.....Poor, **Average**, Good
 - Pew upholstery intact (suggest new pattern)
- Equipment.....Poor, **Average**, Good
 - Microphones- New/ Good
 - Piano - New/ Good
 - Orhan- Old/ Poor
- Craftsmanship.....**Poor**, Average, Good
 - No unique attributes (add more style)
 - Water damage on walls/ceiling (figure 1)

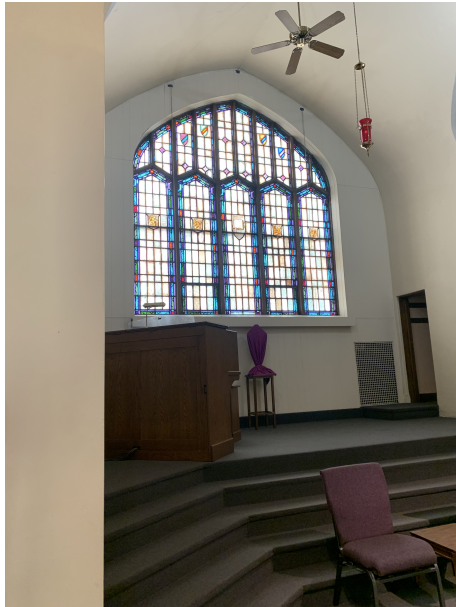
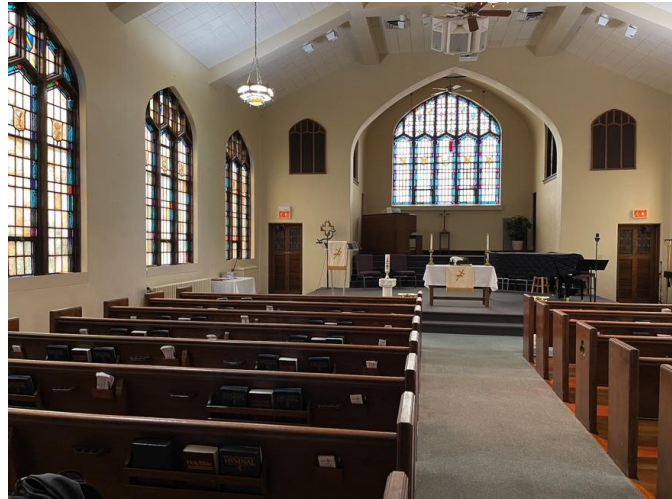
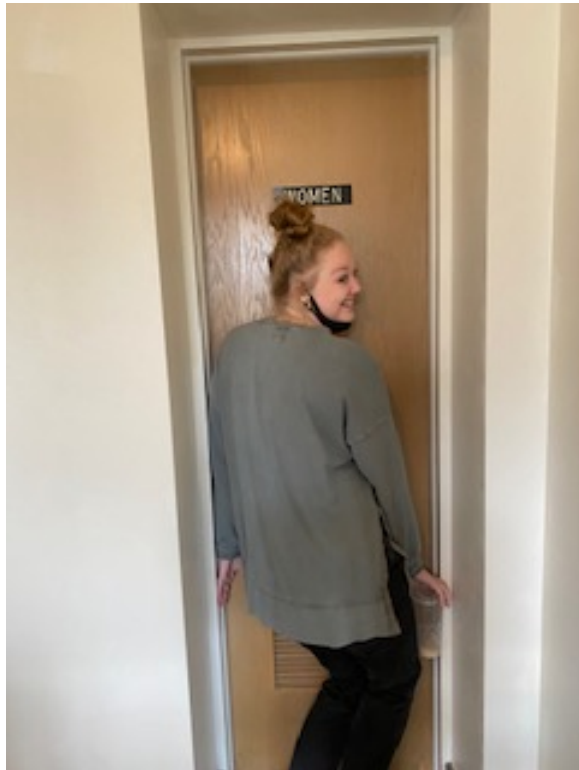
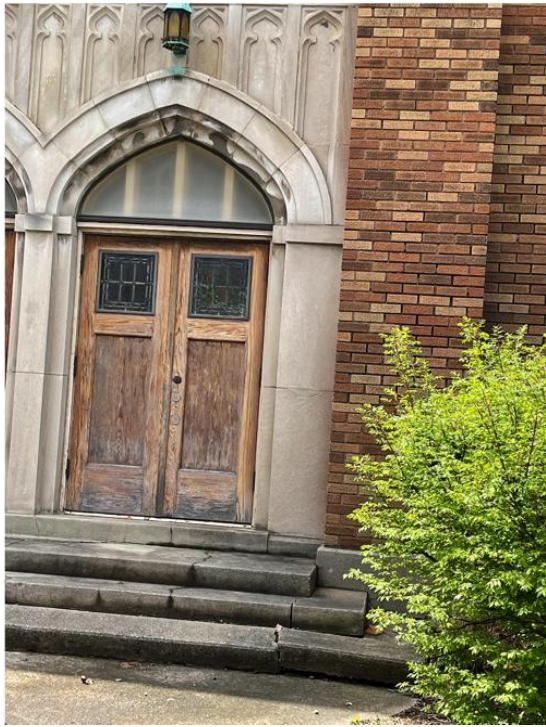
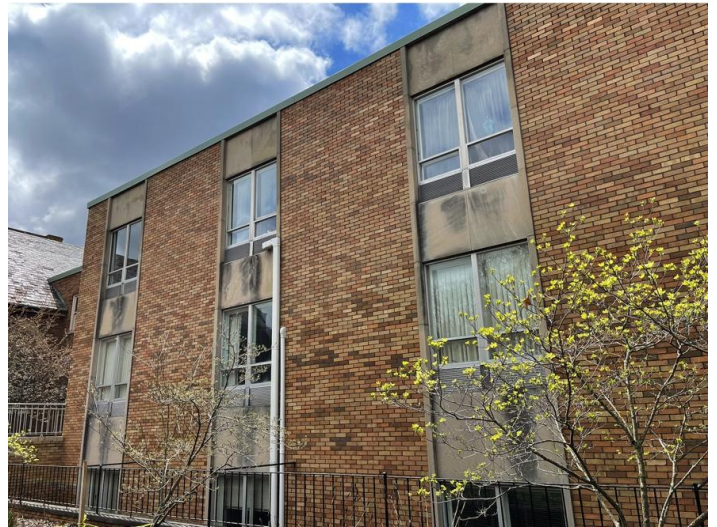
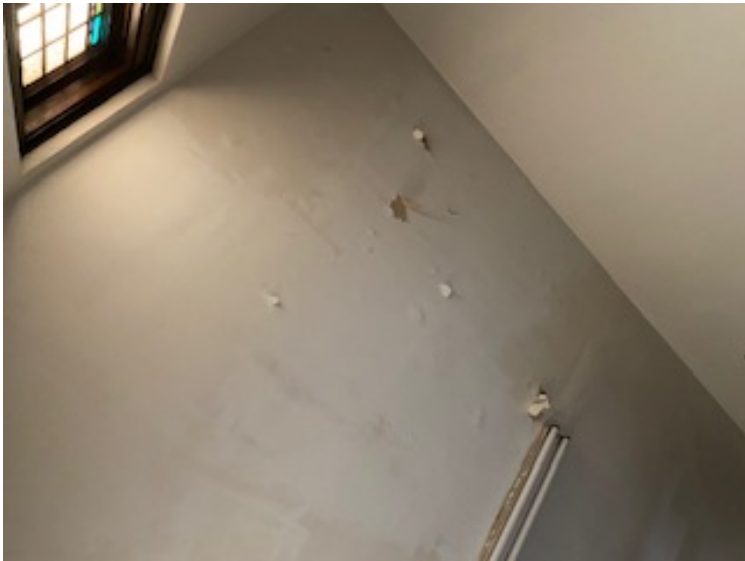
Thermal Images from CM Members

The group of images above display problems with the insulation in the building. Bad insulation is common around windows but in areas such as the one in the very first picture, it can lead to more problems. From an energy saving standpoint we recommend getting some of these spots looked at in order to save money from heating in the future.

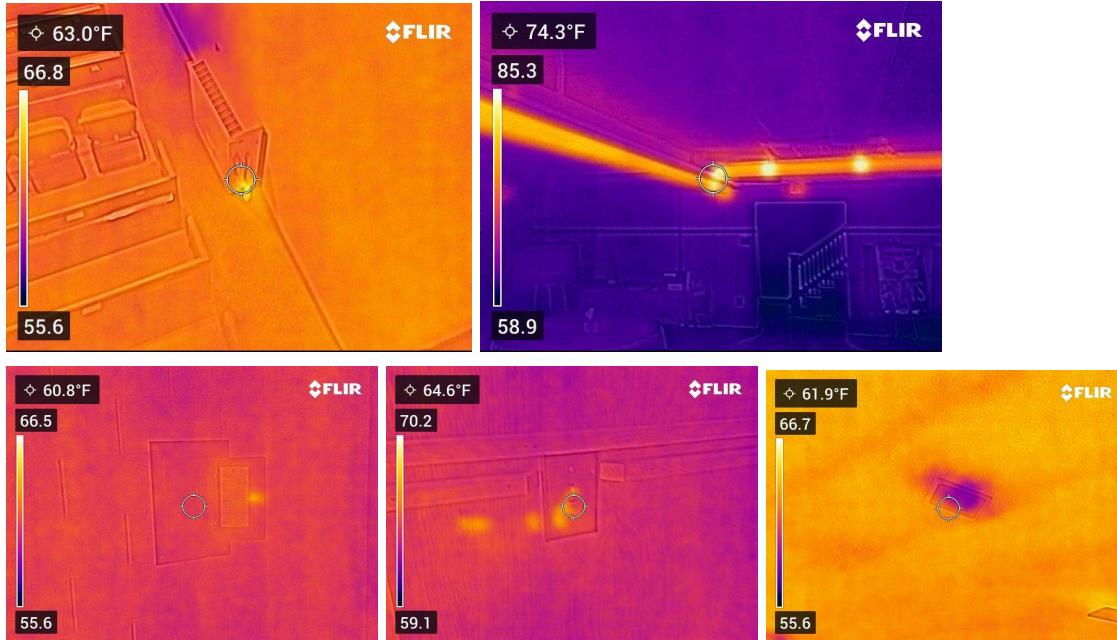
This group of images displayed above show hot or cold spots in various places around the church.

One of the most notable things we noticed when walking around the church was the lighting. It was extremely old and not energy efficient at all. One suggestion could be to update all the lighting to LED lights so not only is it more modern it will save them money in the long run. Another noticeable issue was the poor installation in many locations. This can be seen in the thermal images above. The areas around the window were especially bad. This is costing the church a ton of money and fixing it would be very beneficial to the church in the long run. The dry wall in lots of areas was also just cracked which could be causing the energy bill to go up. Fixing those would be beneficial too.
