Project Title: Using Nature to Redesign Places of Worship in
Muncie, IN

Spring 2021 Work: Post Occupancy Evaluation

Site: Islamic Center of Muncie

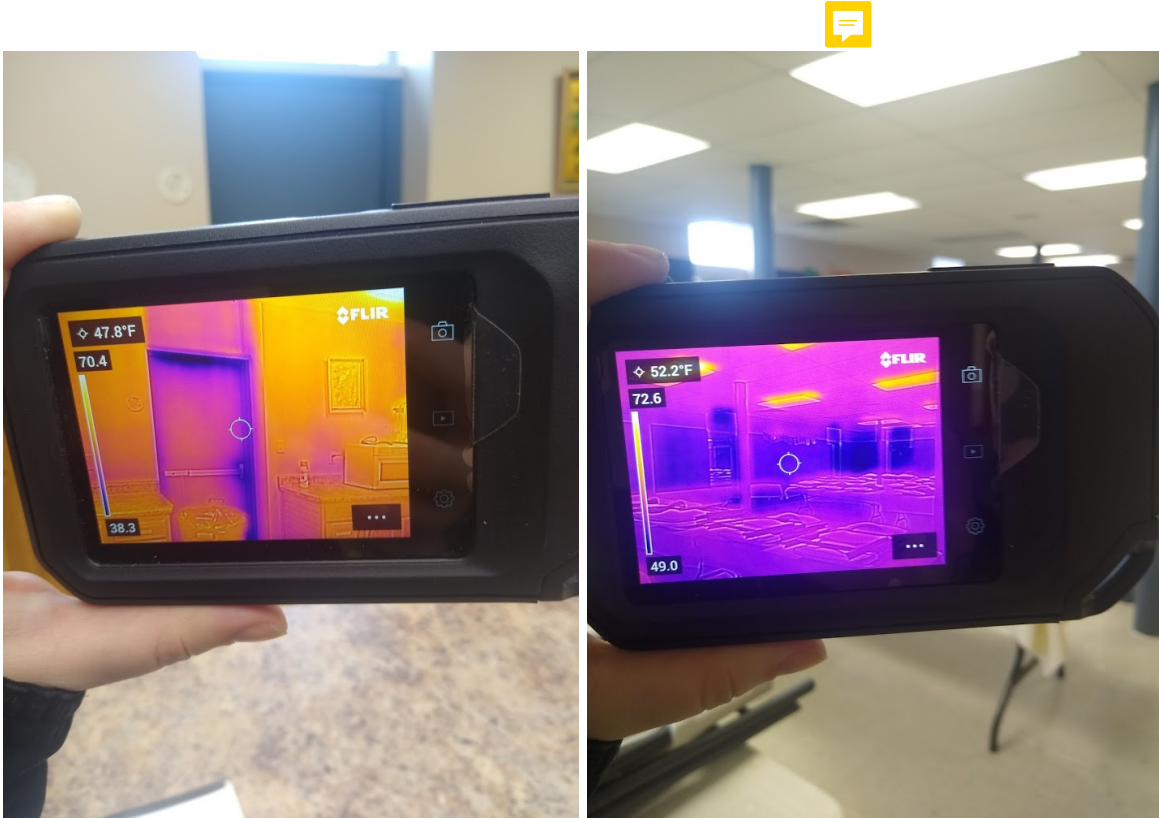
Thermal Camera readings. The blue readings are showing how poor the insulations are, these are readings from downstairs.

- Make the space more accessible
- Implement easier way-finding elements
- Add insulation in basement / colder areas throughout
- Add more biophilic elements
- Add more solar panels
- Implement cohesive finishes / update furnishings

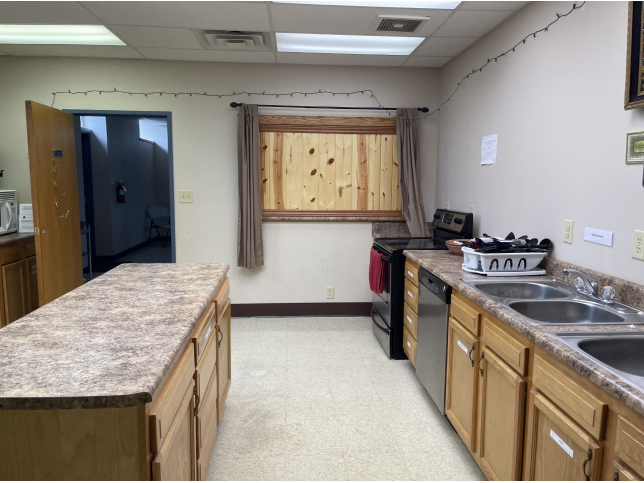
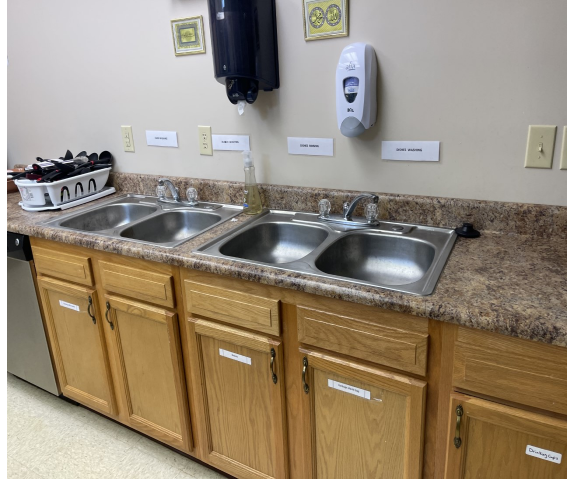
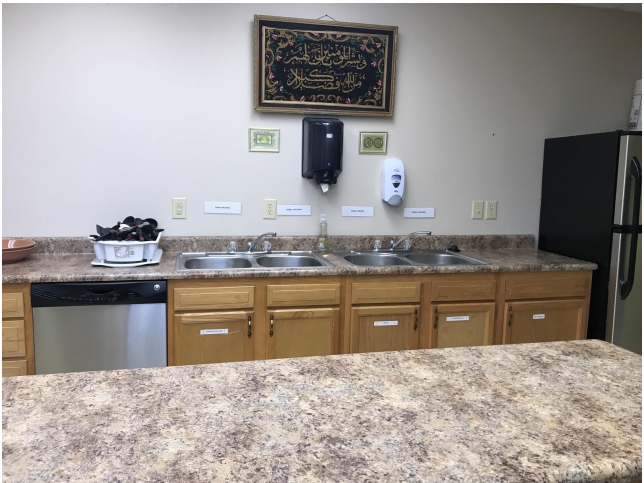
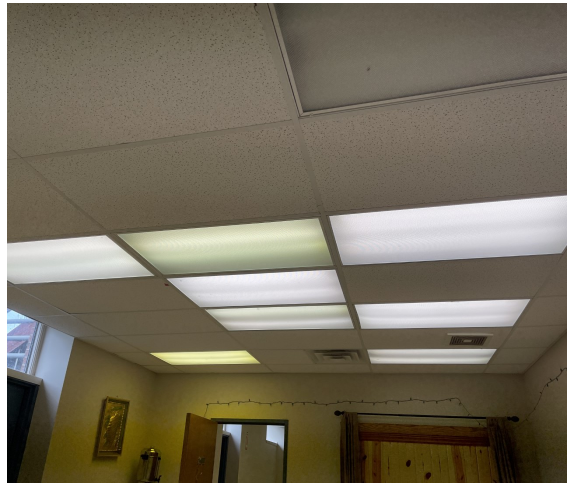
Kitchen in Basement Part of a Multi-Purpose Room - too many light fixtures

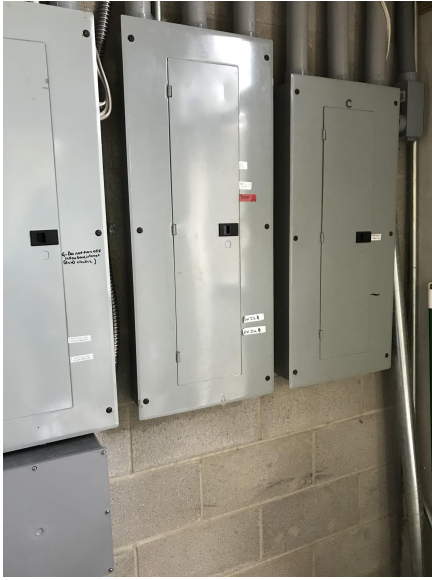
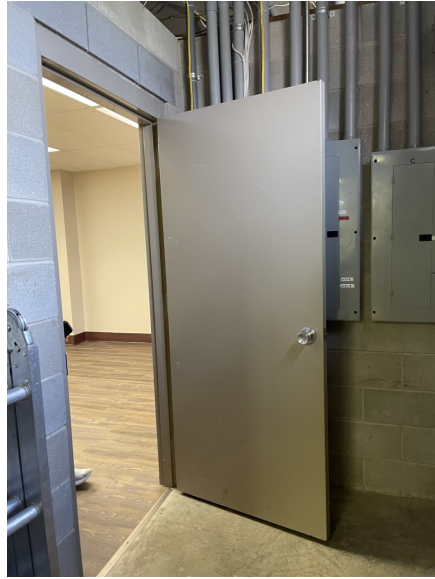
Breaker Panels downstairs - easily accessible to anyone (not good)

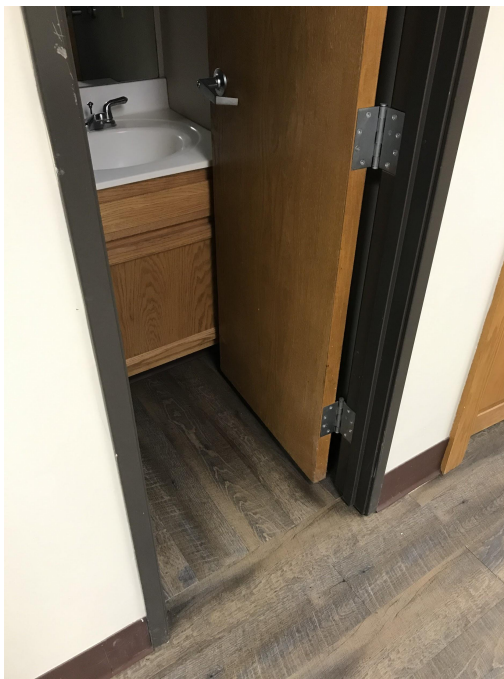
<p>Physical Conditions</p>	<p>Temperature/Thermal Comfort*, Light (Natural/Artificial)*, Noise/Acoustics, Air Quality/Ventilation*, Safety, Trash Removal.</p> <hr/> <ul style="list-style-type: none">● A tad hot on upper level(may be uncomfortable with warm clothing on)● Lighting is a little dull● Foyer has bad lighting● Basement looks unfinished in some areas● Air quality not consistent throughout entire building● Can hear foot step from above (not the greatest acoustics)● Downstairs/basement bathroom too small (does not seem to meet basic ADA requirements.) *see Page 23 Photo 3*● Entrance steps are steep *see Page 28 for photos*
<p>Space</p>	<p>Building Layout, Privacy, Correct Amount, Accessibility, Inclusivity.</p> <hr/> <ul style="list-style-type: none">● Upper level bathroom is a nice size *see Page 30 for photos*● A lot of doors (not very inclusive or accessible)● Accessibility- No ramps outside for wheelchair users, Sharp corners, No way to get downstairs if you are wheelchair bound or can not walk● Kids play area can be unsafe (Floor is hard and can cause injuries)● Bathroom in the basement is badly designed (door is too narrow and not accessible) *see Page 23 Photo 3*

One downstairs Bathroom - extremely small

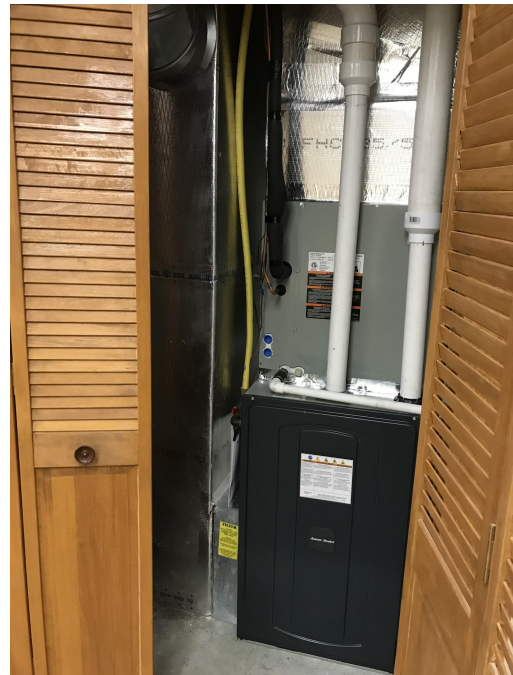
Small closet next to bathroom holding some mechanical equipment - across from children's classrooms and doors are easily opened (not very safe)

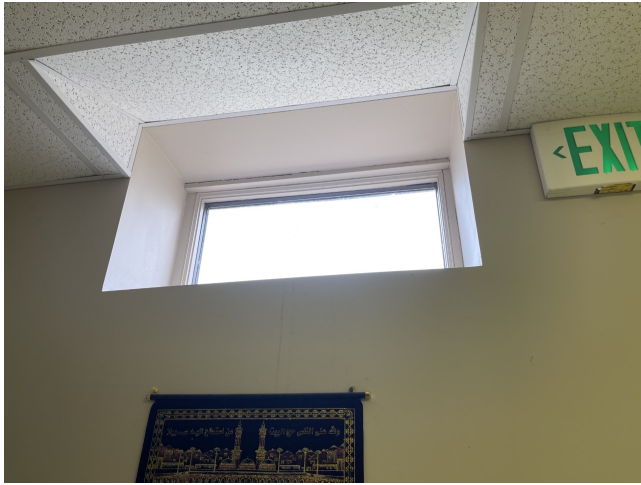
<p>Overall Satisfaction</p>	<ul style="list-style-type: none"> ● Room Design could be much better ● Room colors work for accent walls ● Flooring is sufficient ● Bathroom in basement near children's classrooms needs to be larger ● Overall Aesthetic needs something
<p>Biophilia</p>	<p>Environmental Features, Natural Shapes + Forms, Natural Patterns + Processes, Light + Space, Place-Based Relationships, Evolved Human-Nature Relationships</p> <hr/> <ul style="list-style-type: none"> ● Clerestory windows in the basement *see Page 24 Photo 1* ● Wood Finishes

Clerestory windows throughout basement

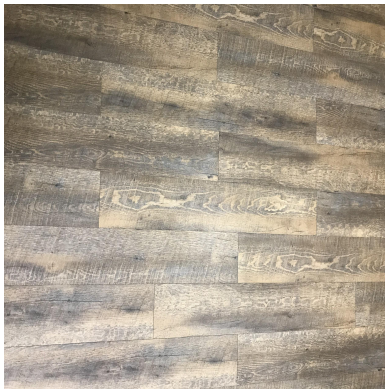
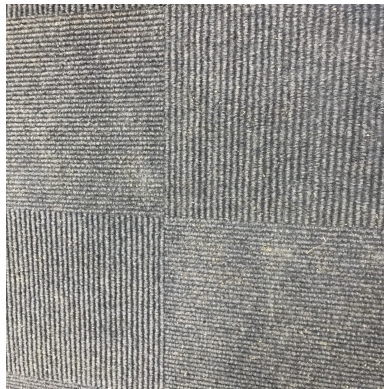
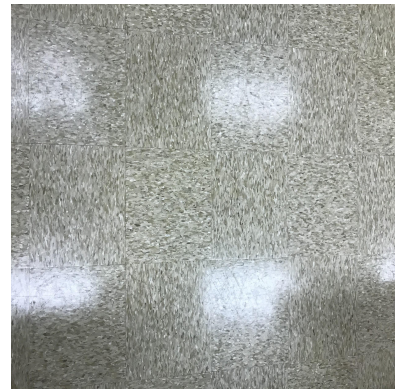
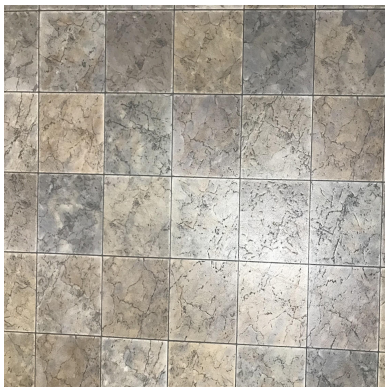
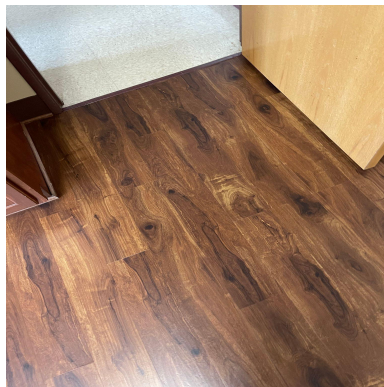
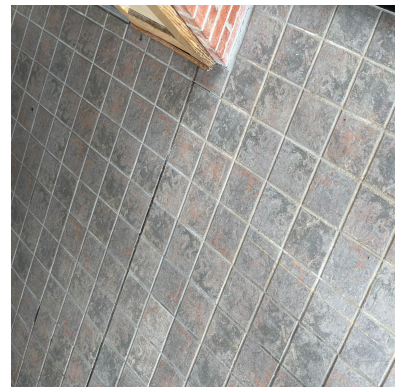
Ergonomics	<p style="text-align: center;">Furniture, Controls</p> <hr/> <ul style="list-style-type: none">● Furniture is a little old● Lots of wood furnishings● Outdated furniture
Aesthetics	<p>Floors/Walls/Ceilings, Furnishings, Equipment, Color, Quality, Durability</p> <hr/> <ul style="list-style-type: none">● Colors are bland throughout the building except for kids learning rooms. *see Page 27 for photos*● Colors in kids rooms are very bright and can possibly be distracting.(orange, Blue, Etc)● furnishings/finishes are inconsistent and changes a lot throughout the building. *see bottom of Page 24 for photos*

Variations in the flooring throughout the whole building

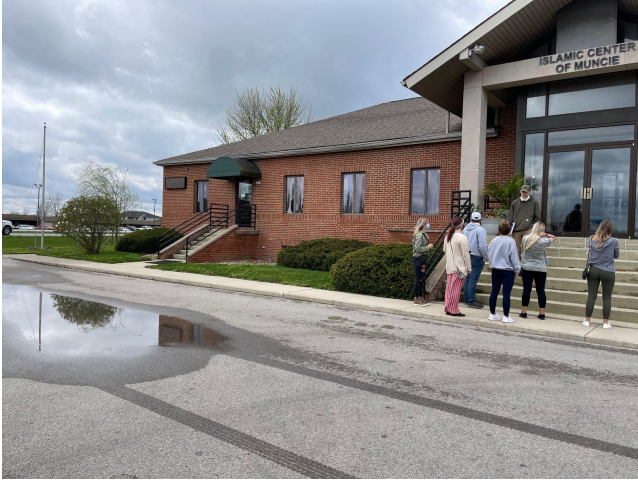
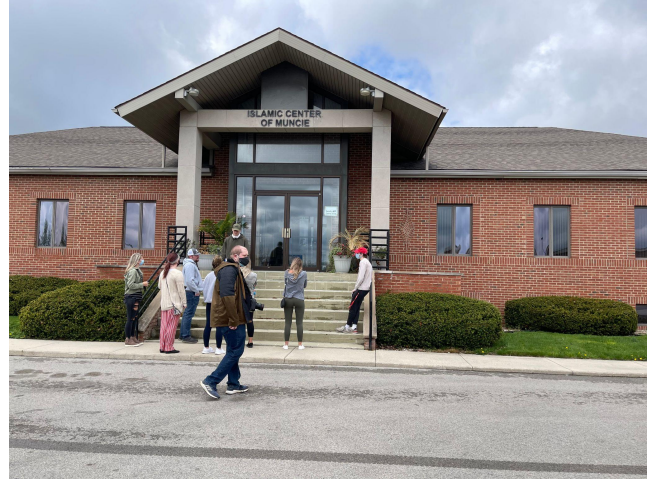
Exterior shots of the building (East side- main entrance)
Step steps to approach main doors

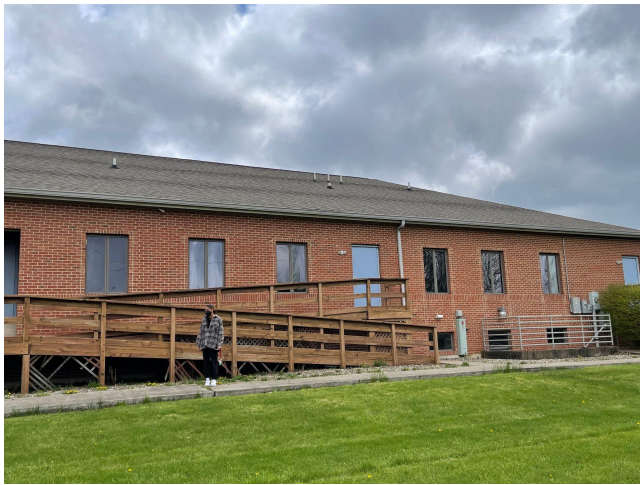
Rear side of building - has a ramp for wheelchair accessibility

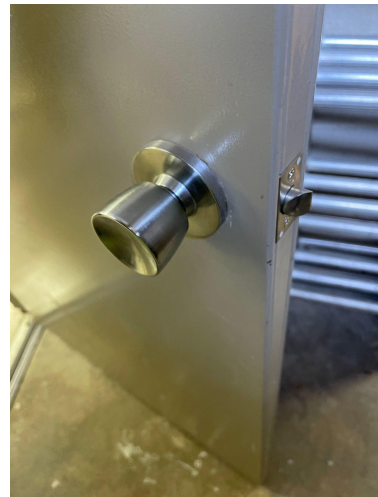
Door knob to room with electrical panels - does not have a lock so anyone can open it at anytime
