USING NATURE TO REDESIGN PLACE OF WORSHIP IN MUNCIE, IN
POST OCCUPANCY EVALUATION REPORT
ISLAMIC CENTER OF MUNCIE,
IMMERSIVE LEARNING GRANT

5141 HESSLER RD, MUNCIE, IN 47304
SPRING 2021

TEAM 5: Genevieve Goldthorpe, Emma Peeler, Elkah Devoe, Cylie Collins, Madison Hornung, Ben Egenolf, Austin Cain, Evan Galbraith, Ashton Hamrick

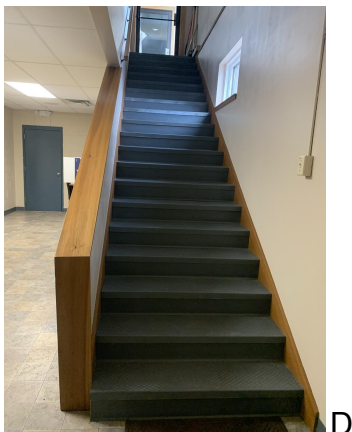
Stairway from basement to entrance:

Small window for natural light.

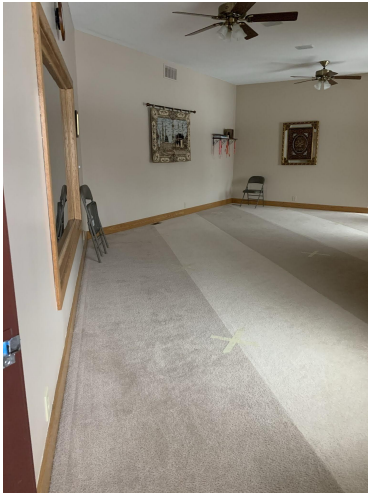
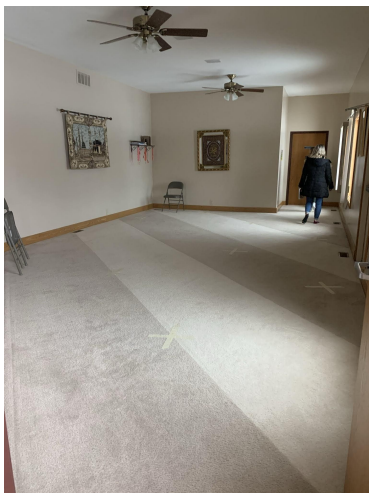
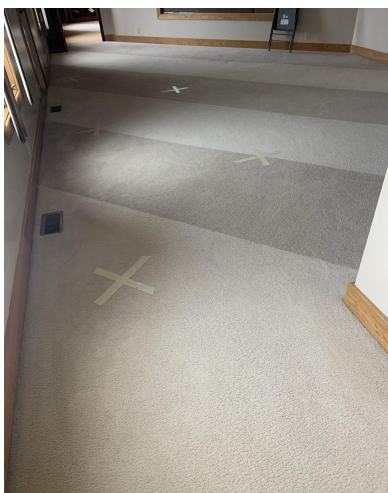
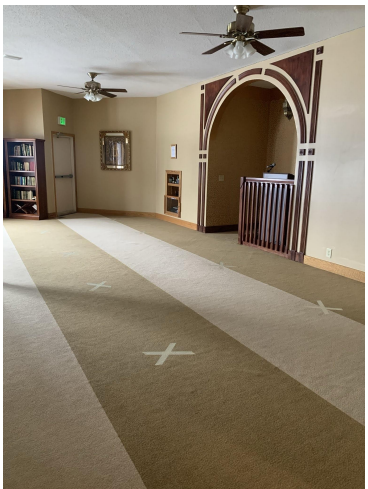
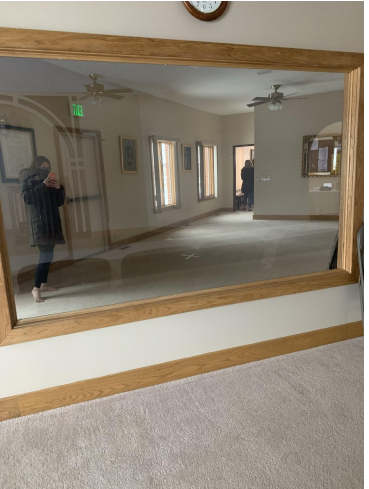
Women's Worship Room: (M)

Upstairs- the lighting is much better, especially through the entrance area and the coat room, but the library could use better lighting. The men's worship room has a well lit area from natural and artificial lighting, but the girl's worship room needs more natural lighting.

Since the window between the two worship rooms is tinted enough you are unable to see through it, it could be removed and replace the windows in either worship room to allow in more natural light.

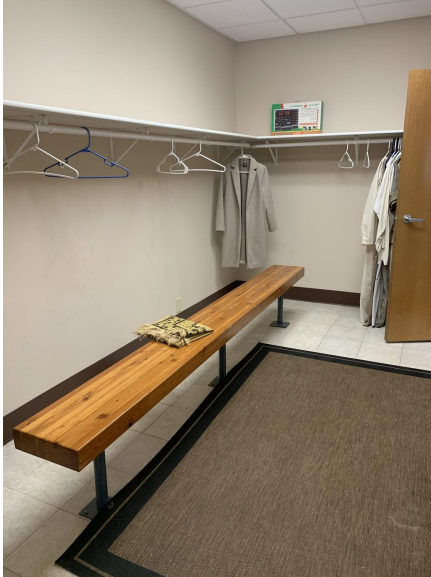
Cubby area at main entrance: (C) This room has good lighting; area is very bright and well lit).

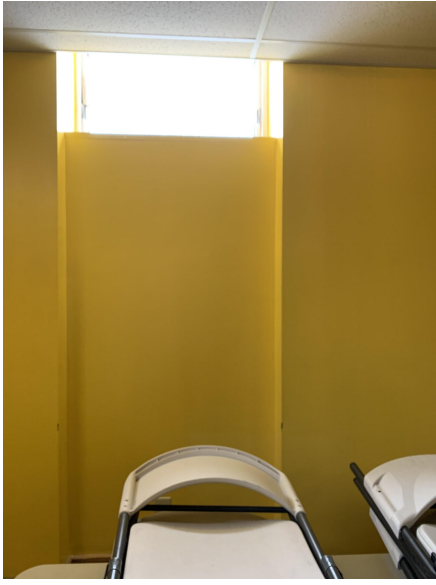
Downstairs- There were windows but located in weird spots. There is not much natural lighting coming from the small windows and the lighting that is coming in is not working well with the space.

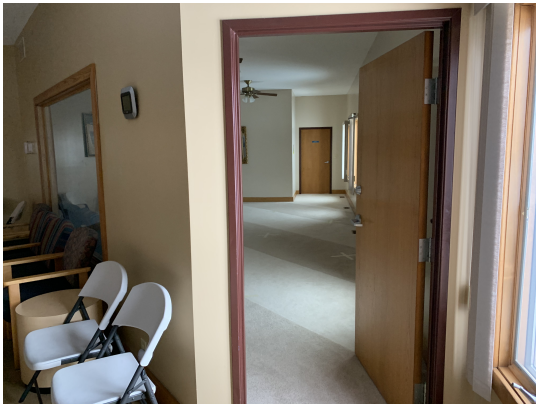
(basement window)

Upstairs- Could be more natural lighting upstairs but overall ok. The men's worship and the library have the most natural lighting, but there could be more implemented in the women's worship room and the coat room. The coat room could be redesigned to have windows on the exterior wall and have glass panels between the entryway to let in the natural light.

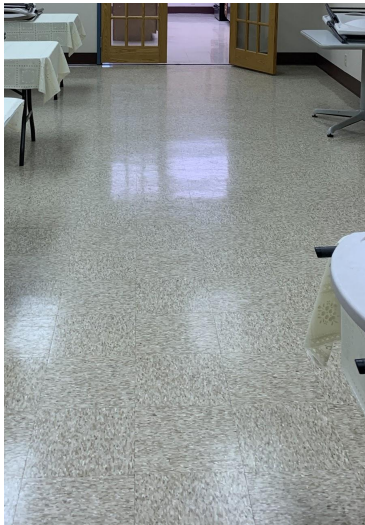
(L)

Some of the flooring was ok. Parts of the basement had a vinyl flooring- but some flooring was old and needs to be updated for non-slip qualities.

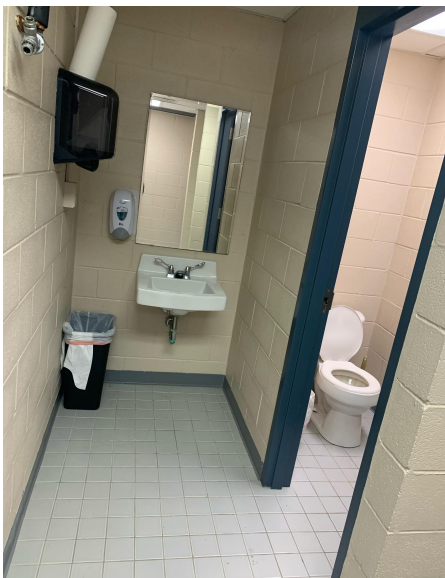
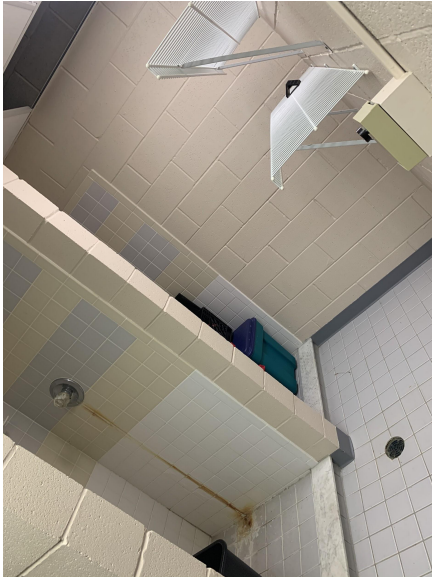
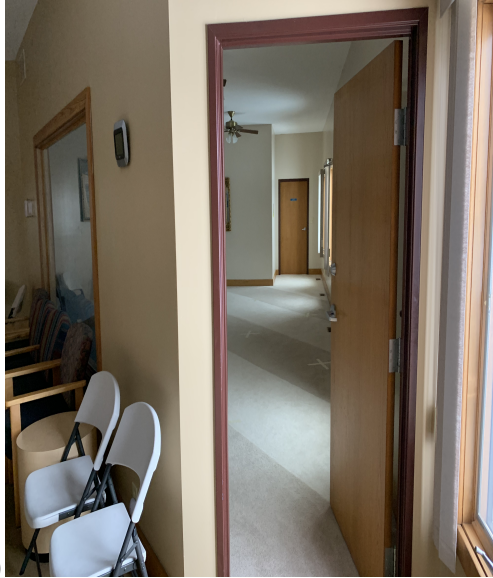
There also were not many locks on the doors.

Bathrooms did not have gender signs.

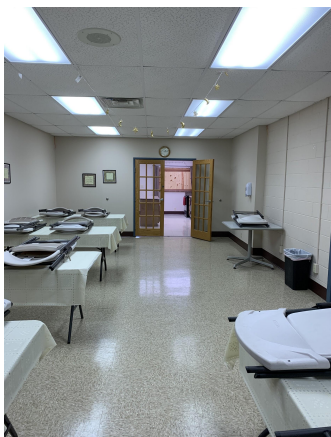
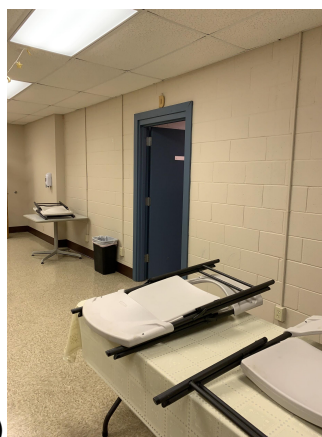
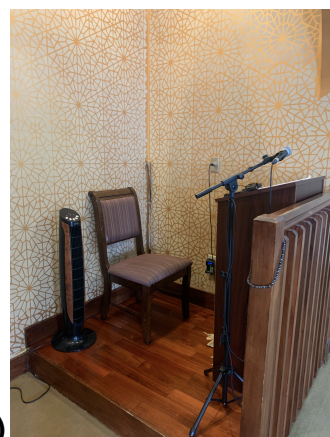
-The furniture was very temporary furniture. Not inclusive at all. Needs to be updated and well thought out.

-Speaking during prayer is a volunteering option by anyone who chooses to do so, but the space behind the microphone is elevated and has very little room to maneuver.

6. New furniture that has a more biophilic design to it would create a more welcoming and inviting environment. The chairs and tables found downstairs are very temporary furniture creating an unwelcoming feeling to the basement. Adding some lounge furniture in large areas as well as more permanent dining furniture is recommended.
7. Paint and flooring correlating with each other throughout the building would be recommended as well. Research would need to be done to make sure colors connect with the history and religion.
8. Landscaping is another key point that would add a more biophilic touch to the building. Adding trees and more shrubbery would limit the busy noise from the road right next to the building as well as create more habitats for wildlife. This will eventually lead to more peaceful noises, such as bird noises.

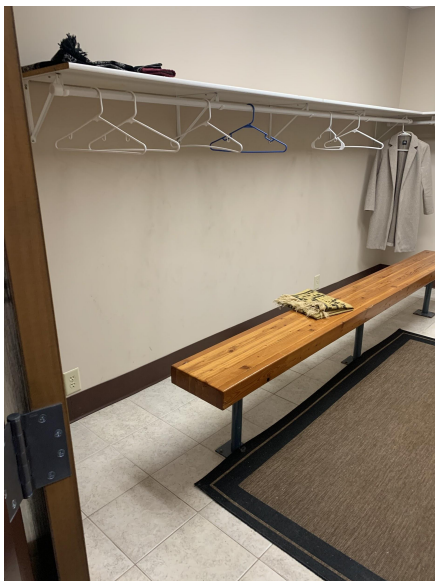
(small cubby area off of entrance)

- The entrance to the building is slightly confusing due to there being 3 doors with steps located in the front.
- When you enter the building there are beautiful rugs but all rooms are closed off and there are no signs or labeling.
- When you enter you see a blank wall with a huge closet with a bench in it on the right. The closet size is unnecessary and could be shrank to open the entrance up.
- The vestibule was very small and full of random materials (tools, plants, salt, etc). It was also very closed off.

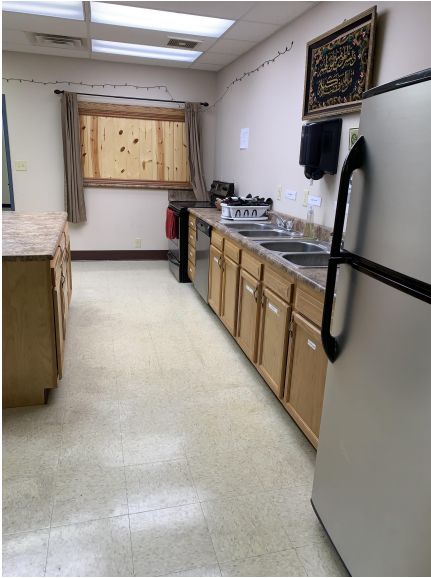
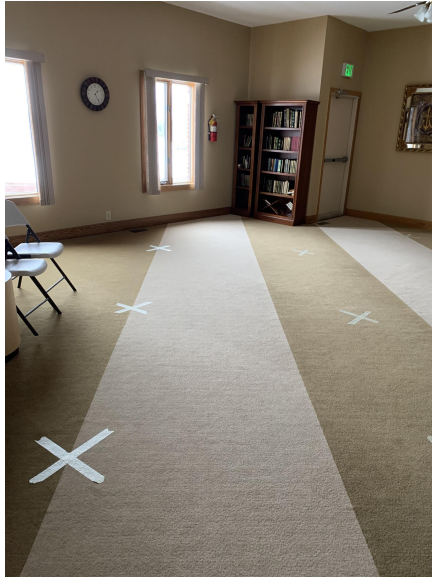
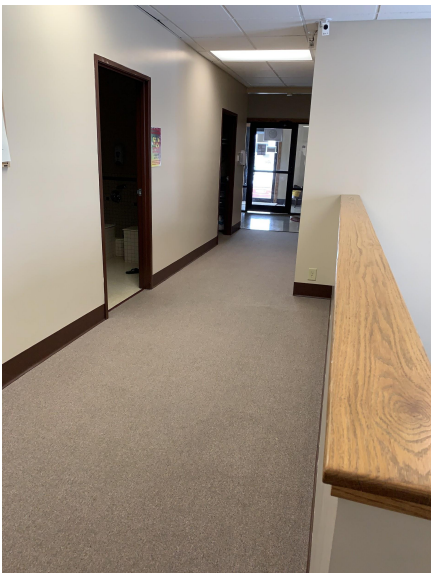
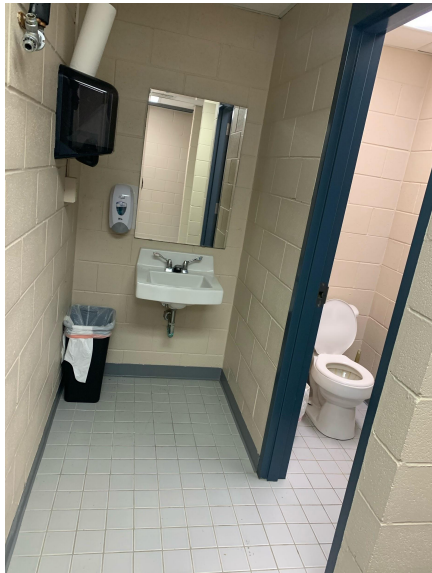
-Flooring is not all the same and does not match. Not visually pleasing.

-Flooring in the restrooms could use the most repair. The rest of the building has flooring that is not very aesthetically pleasing, but is in good condition.

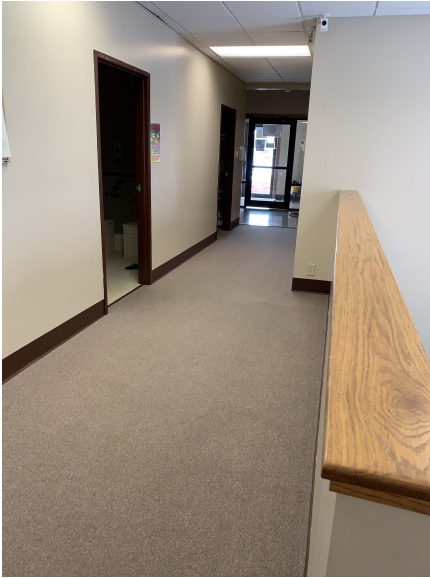
(G)

- The walls and trim are all the same colors throughout the building. Very boring. There is a lack of decor.
- A few rooms in the basement have very vibrant colors that bring excitement but do not mesh well with the rest of the building.

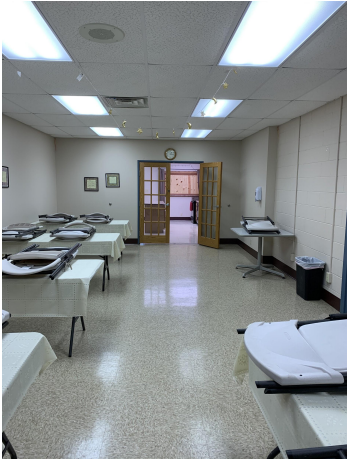
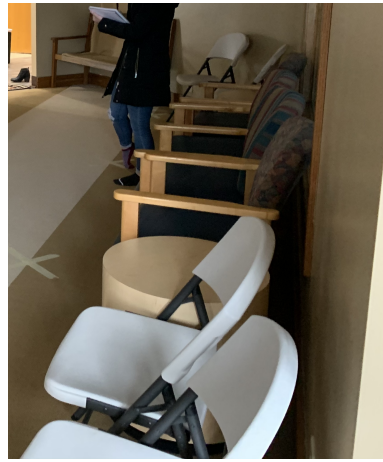
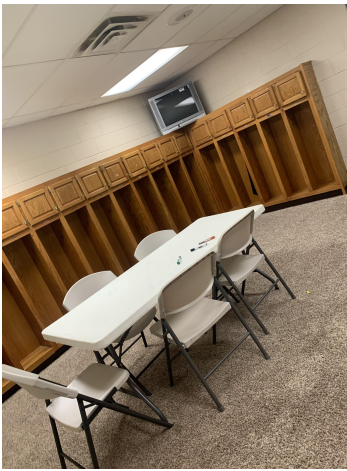
- The furniture looks to be temporary pieces. They are not very durable and not made for the space.

-The furniture that was present was not great quality and seemed temporary.

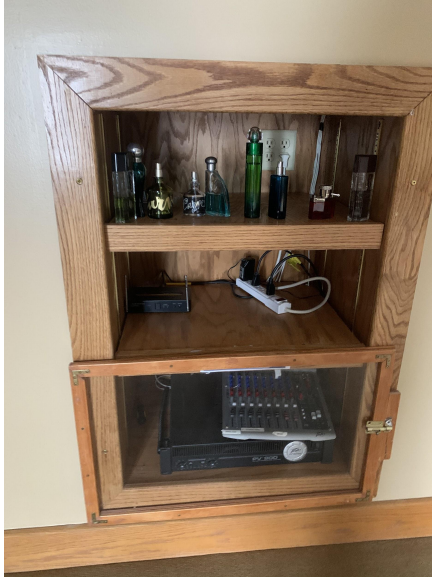
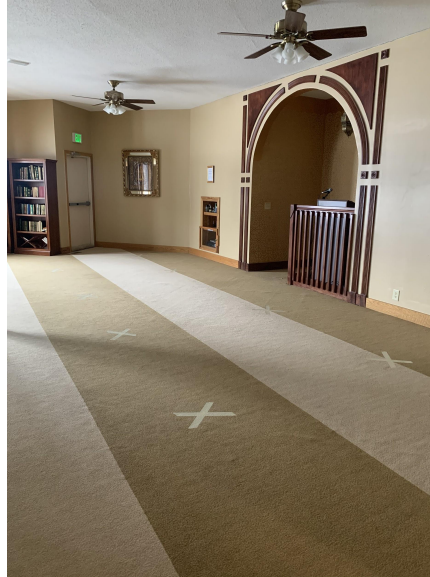
(N)

-Furniture is plastic and the finishes are old and run down.

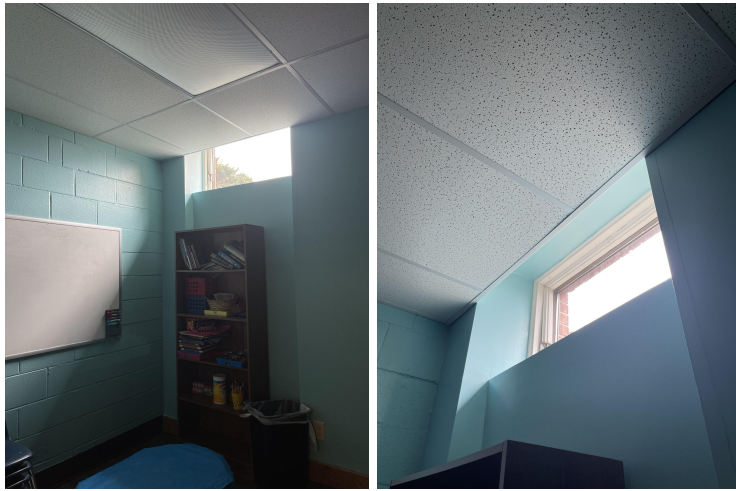
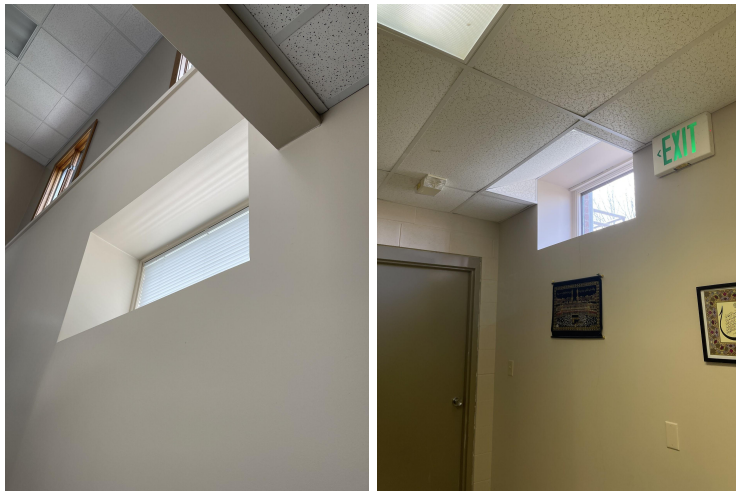
Basement Windows:

- There were a few plants in the vestibule but there more plants would create a better connection with nature- especially downstairs.
- The basement has little to no visual connection with nature because of the small windows.
- A use of a water feature within the lobby would also be a great way to add an acoustical connection with nature as well.
- The prayer room upstairs overlooks the yard in the back of the building.

1. Install better installation in the walls, especially around the windows to prevent heat loss.
2. Caulk or replace the windows, to create a tighter seal preventing drafting and heat loss.

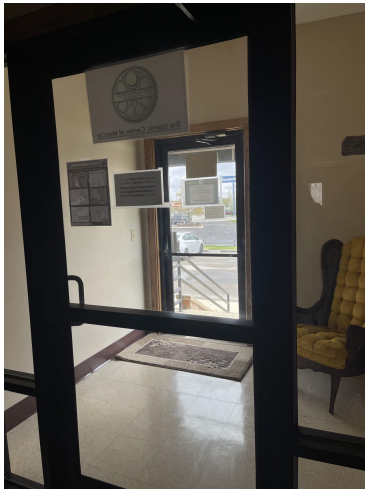
(A)

- Yes- the lobby needs to be the focal point. Plants and details could be added to make a more welcoming environment.
- Bringing in fake plants would be a good option for the basement since there is not much natural light down there and the plants in the lobby area are not well taken care of.

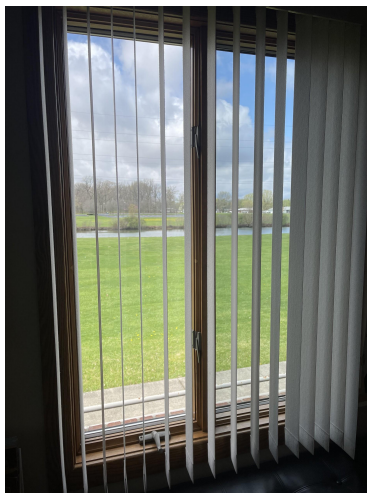
(N)

(large windows off of the prayer room provide a lot of natural light)

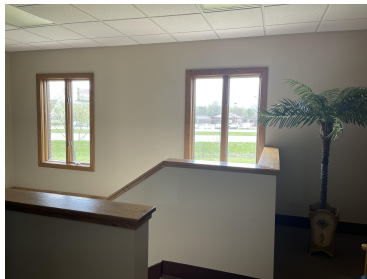
(H)

-These windows are found above the staircase leading to the basement.

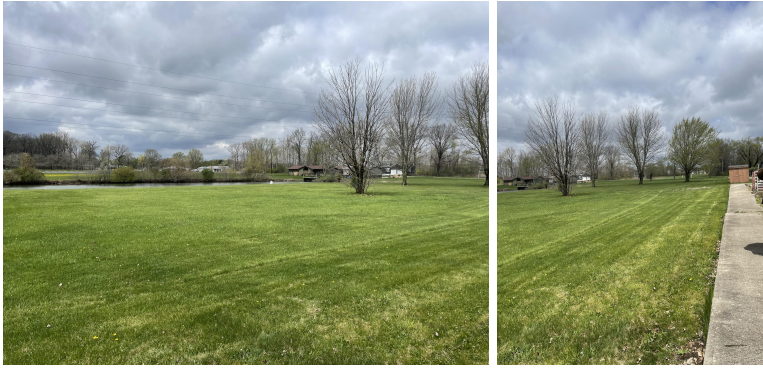
-(There is a lot of potential with the landscaping off of the prayer room. The area is very open and there is a pond in the back. Adding landscapes such as trees and/or sculptures will add a more visual pleasing yard as well as help limit the noise coming from the road.)

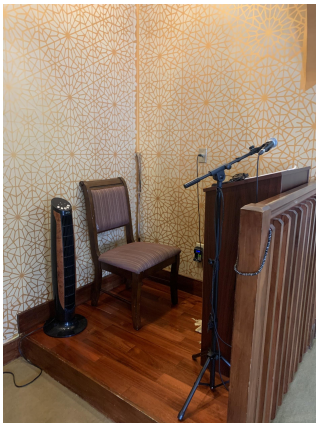
(N)

-There are patterns but they do not relate to nature. The only pattern found that could relate to nature was this pattern- could be referred to as a flower pattern.

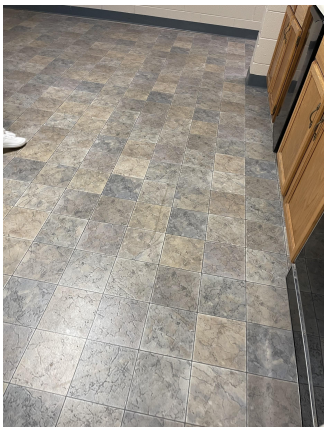
(F)

(This flooring imitates stone which is a natural pattern)

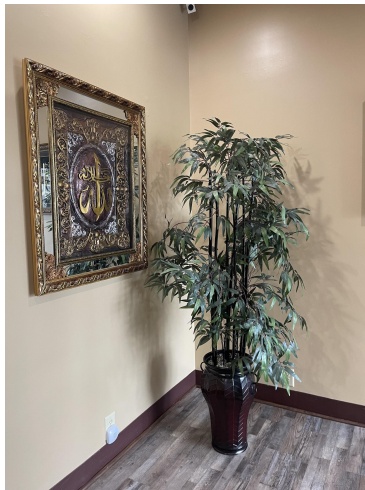
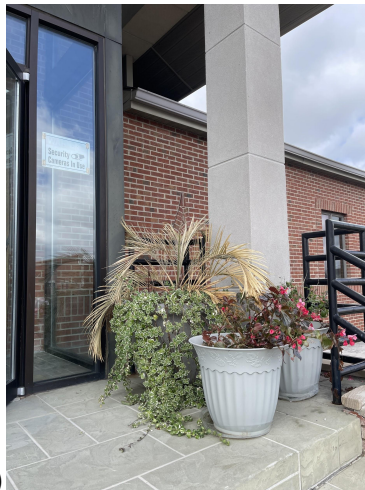
(A)

-There are no recycled materials, or skylights. There is one plant in the building which is located near the entrance but it is fake.

(plant found near main entry) (plants found outside)

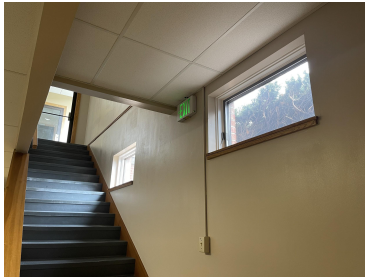
(A)

-Yes because the basement goes from a kids area and on into a large gathering area, a sauna, a kitchen, and other private bathrooms and showers. The space could use much more detail from the religion and this could also be a form of wayfinding since the basement is so confusing.
