**Provost Immersive Learning Grant
Using Nature to Redesign Places of Worship in Muncie, IN
Spring 2021: Post Occupancy Evaluation
Islamic Center of Muncie: 5141 Hessler Rd, Muncie, IN 47203**

**ID Members: Abby Sprague, Halle Schrank, Lauren Cloonan, Lesli Mackey, Therese Jirgal
CM Members: Anthony Kahl, Matt Combs, Nathan Witty, Dayton Webster**

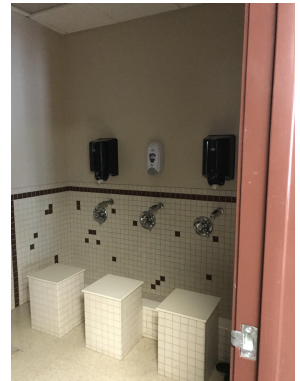
#24

- Women 3 stalls, 1 is ADA accessible, washing/cleansing space
- Mens 3 stalls, 1 is ADA accessible, larger washing/cleansing space
