RIVERSIDE METHODIST CHURCH POST-OCCUPANCY EVALUATION

Project Title: Using Nature to Redesign Places of Worship in Muncie, IN

Spring 2021 work: Post Occupancy Evaluation

Site: Riverside United Methodist, 1201 Wheeling Ave, Muncie, IN 47303

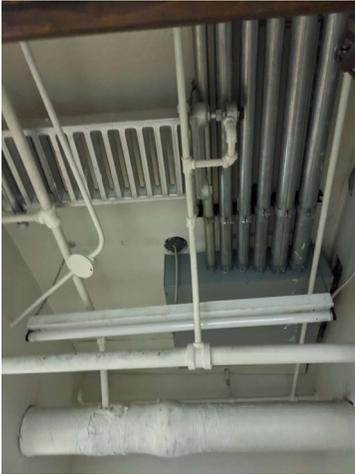
11 - Pipes on ceiling

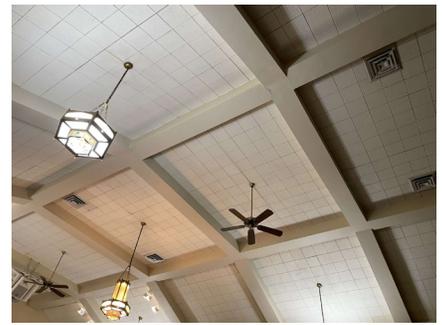
No, each room had dim and broken lighting. (Reference Photos 27 – 32)

Lights were not centered, broken, falling out of ceiling. Large light fixtures, but did not let off a lot of light. (Reference Photos 27 – 32)

29 - Lighting in sanctuary

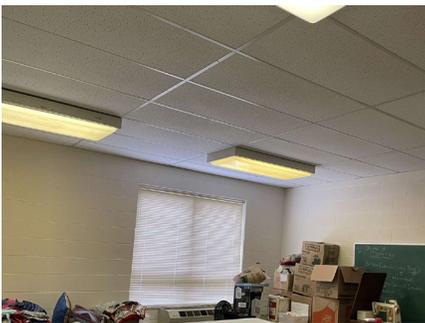
30 - Dim, inconsistent lighting

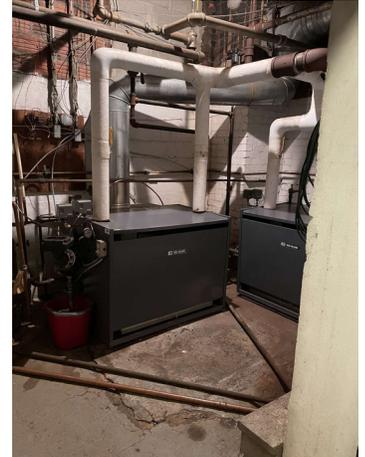
38 - Boiler room

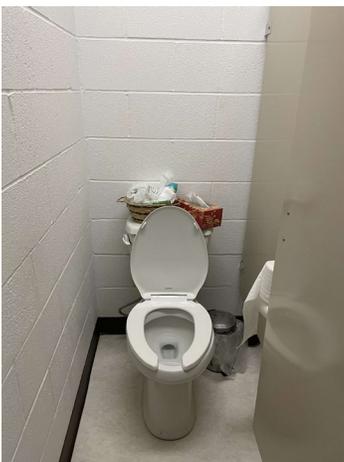
39 - Restroom stall

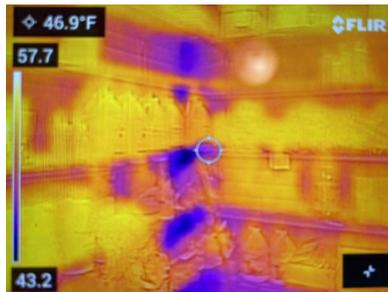
TC-2 - Garage door near boiler room - poorly sealed, losing a lot of heat

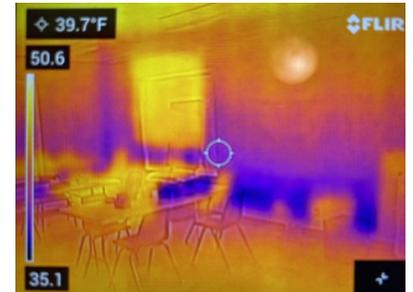
TC-3 - Heat is lost through the baseline of the wall this could be due to many things including poor insulation. This is not a single occurrence many rooms have one or multiple walls with this issue costing the church money in heating and cooling during the summer.

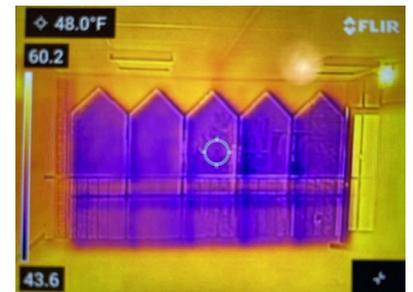
TC-6 - The blue color of the windows isn't necessarily an issue because heat will inevitably be lost through this glass. Although, this thermal reading does make it apparent just how much heat is lost through these windows. It may not be visually appealing but replacing these windows with a wall the church would save money on heating and cooling.

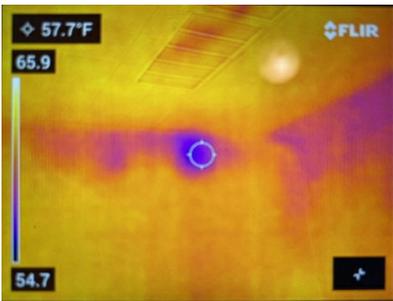
TC-15 - More missing insulation in an upstairs storage room. Renovation becomes more of a necessary decision throughout the process locating multiple rooms losing heat and driving the heating and cooling bills up.

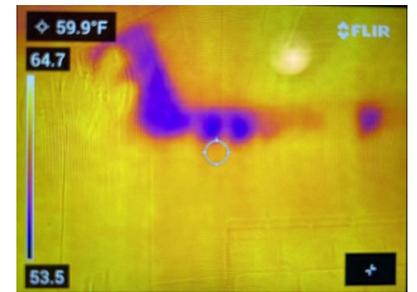
TC-17 - Another upstairs storage room shows extensive insulation damage and possible water damage down the corner of the wall.
